Monitoring Restoration Effectiveness on the Lower Rio Blanco River

J.D. Kurz¹ and D.L. Rosgen²

Lower Rio Blanco River near Pagosa Springs, Colorado

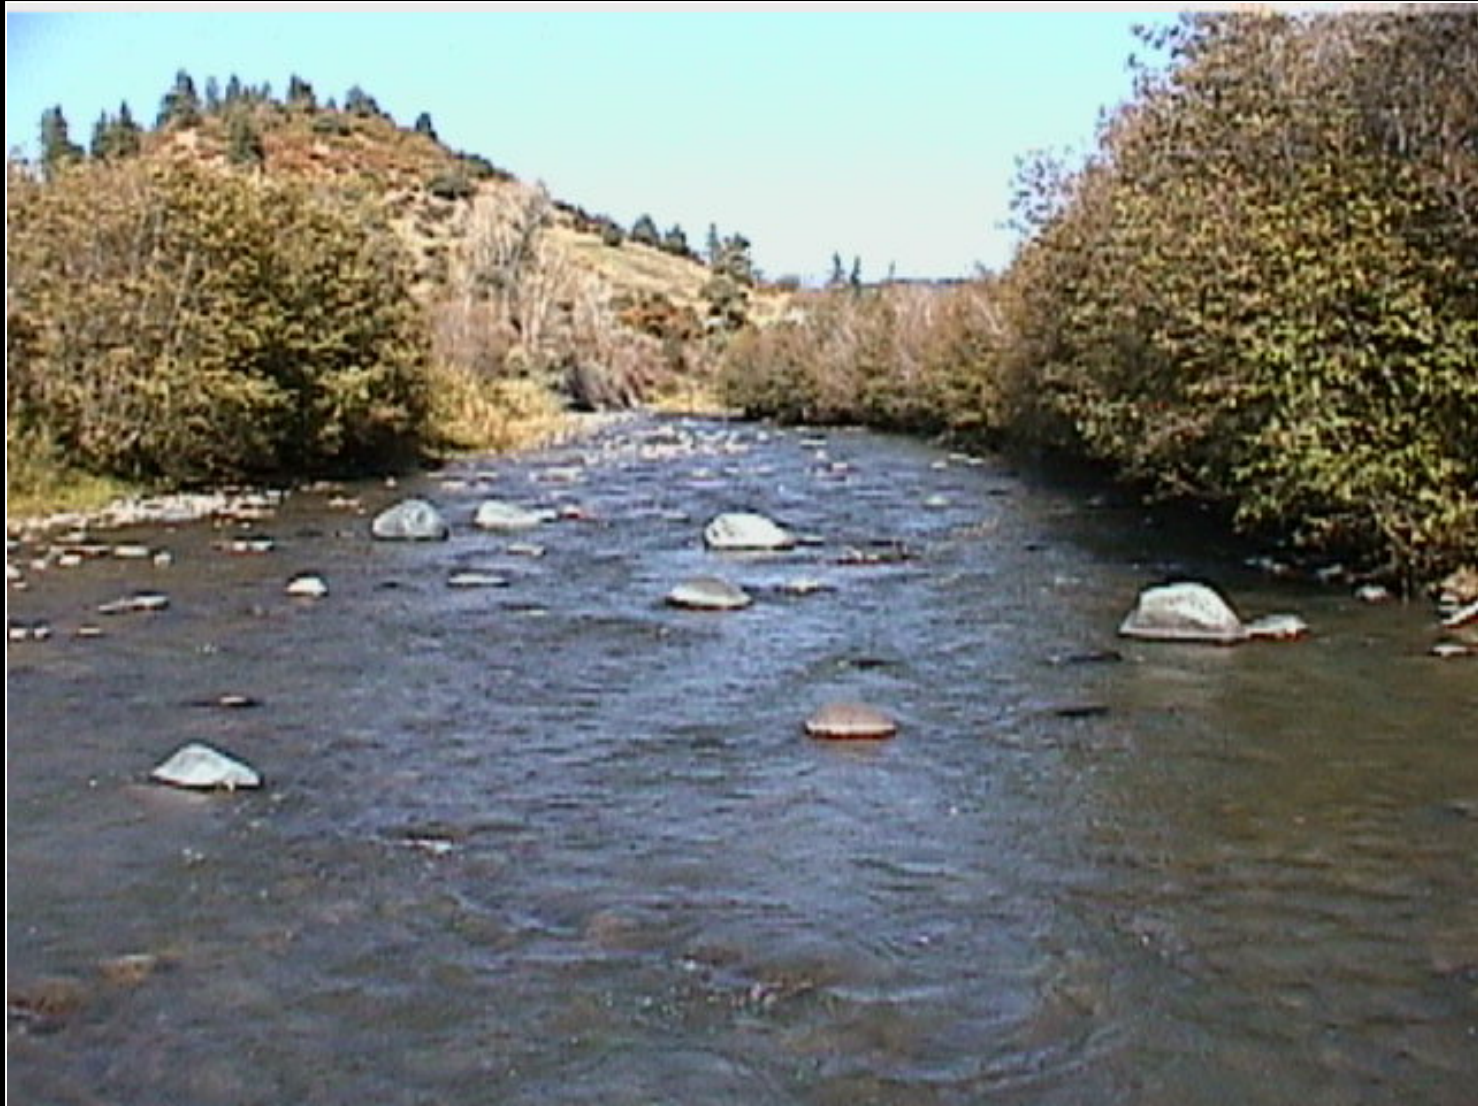
Typical photograph showing the wide, shallow channel at low flow prior to restoration

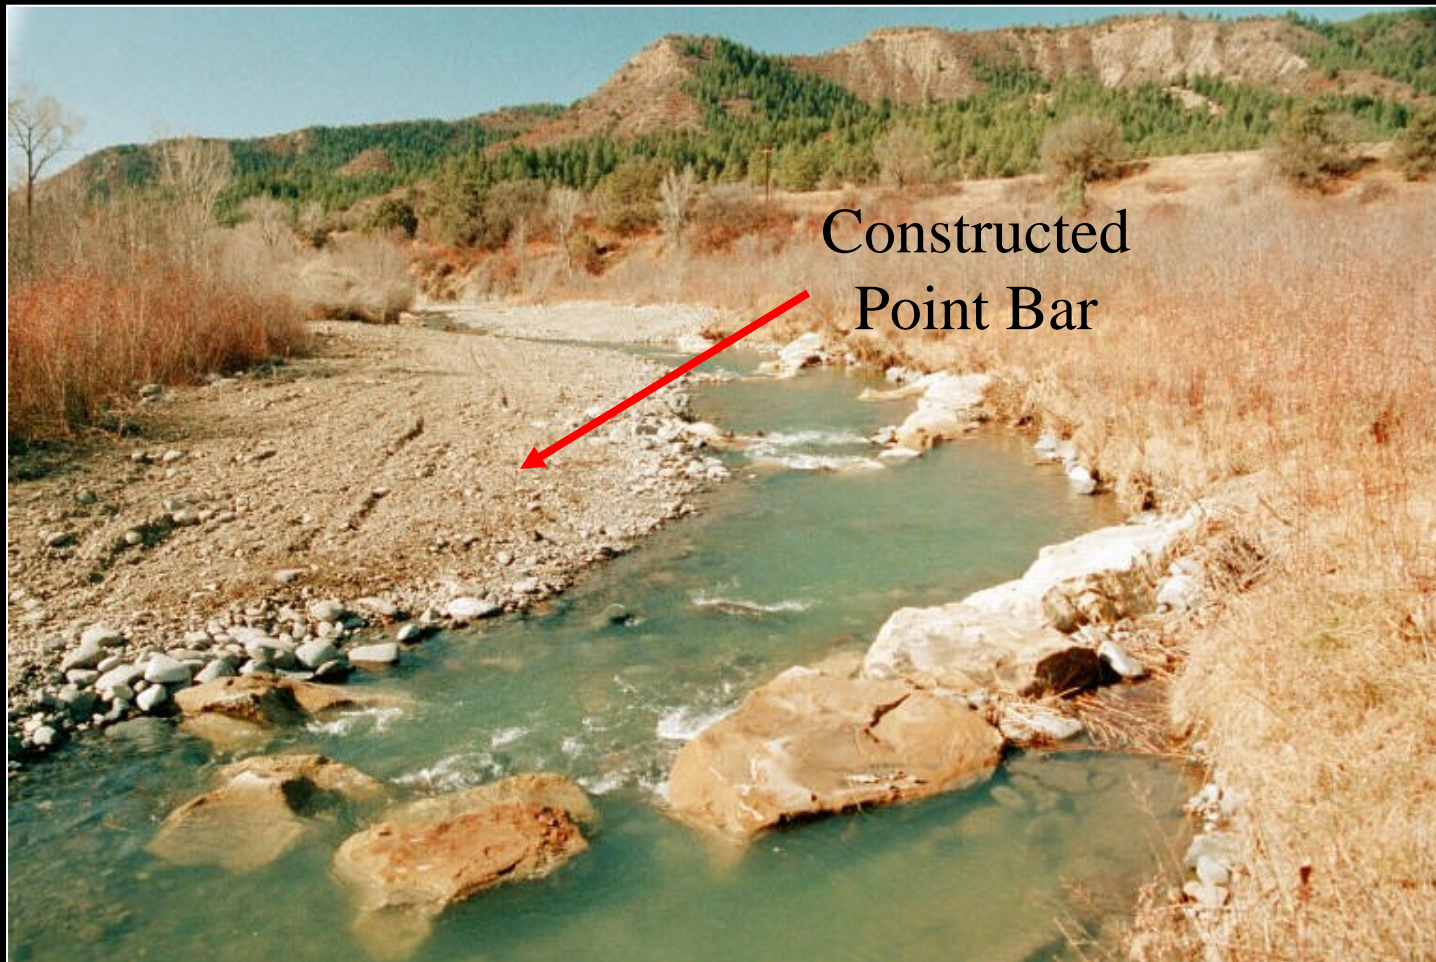
J-Hook Vanes

Reduce bank erosion and maintain deep pools downstream of each structure.

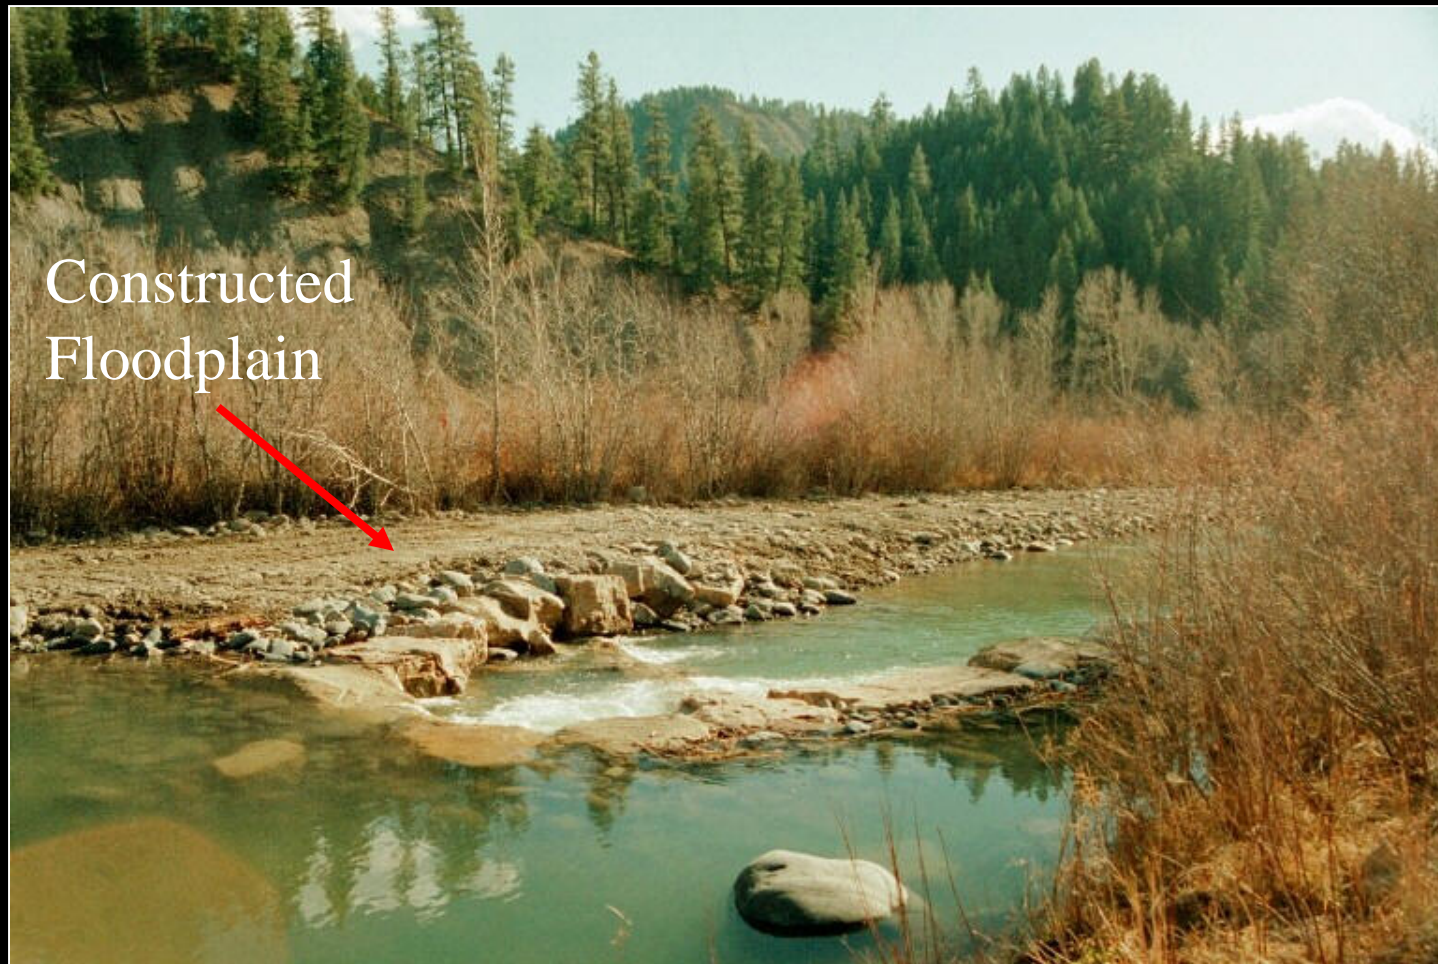
Cross Vanes

Provide grade control, reduce bank erosion, and maintain deep pools downstream of each structure.

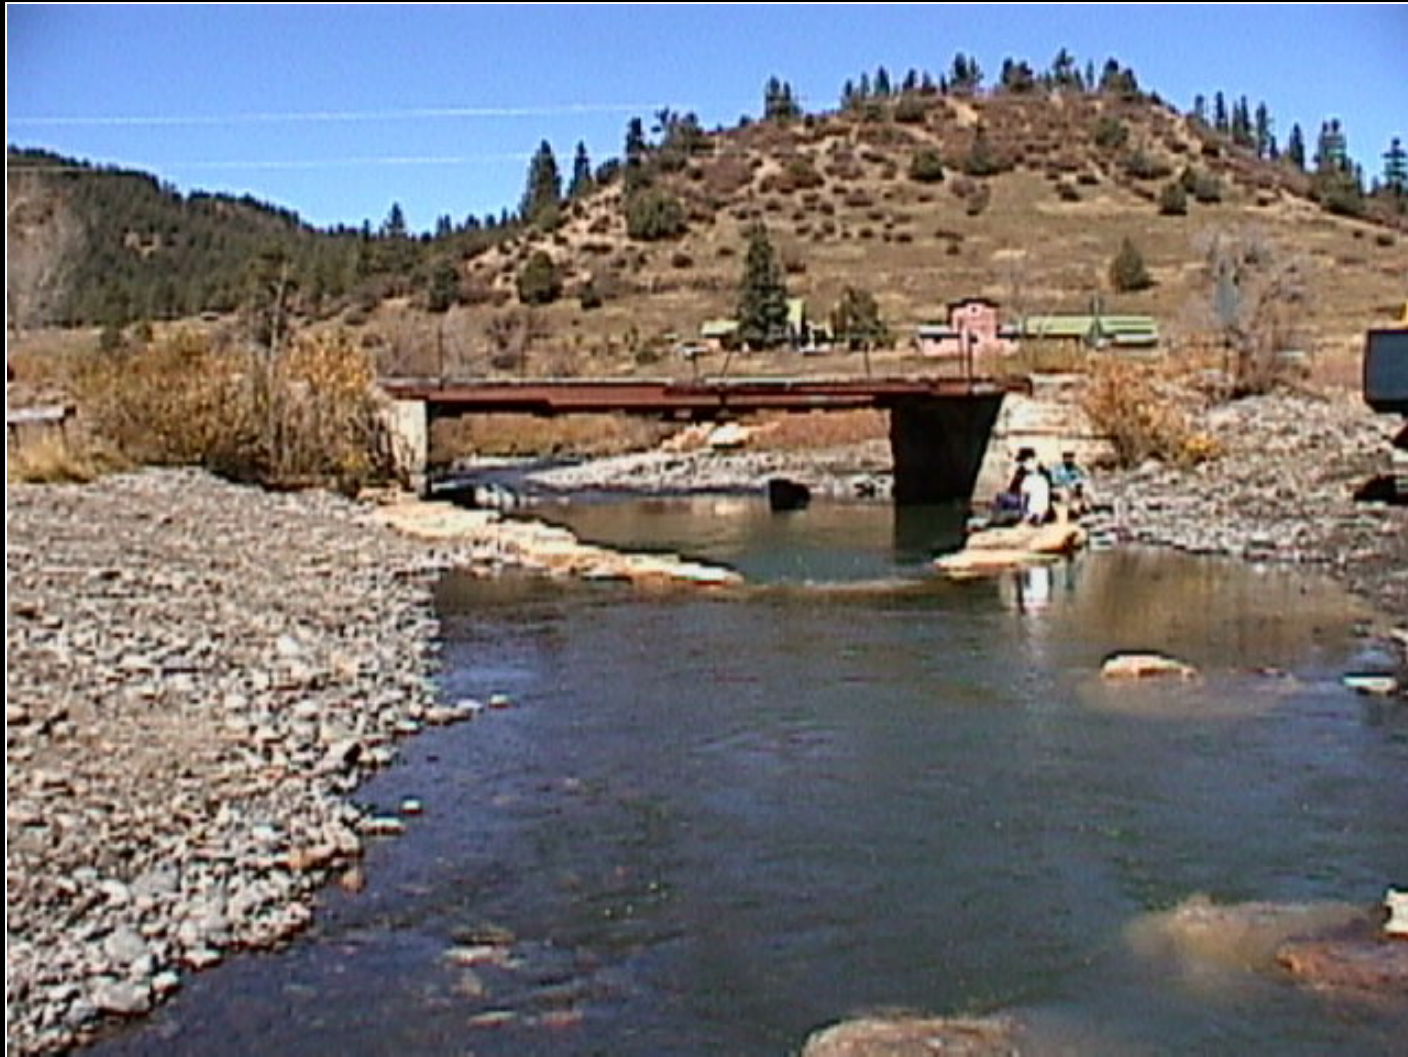
Cross Vanes

Very little bank erosion occurred throughout the restored reach. The lack of bank erosion can be attributed to the bank protection provided by J-Hooks and Cross Vanes, which redirect velocity vectors away from streambanks. The Cross Vane that was installed upstream of the problematic bridge has reduced the stress against the bridge footers.

Provide bridge protection.

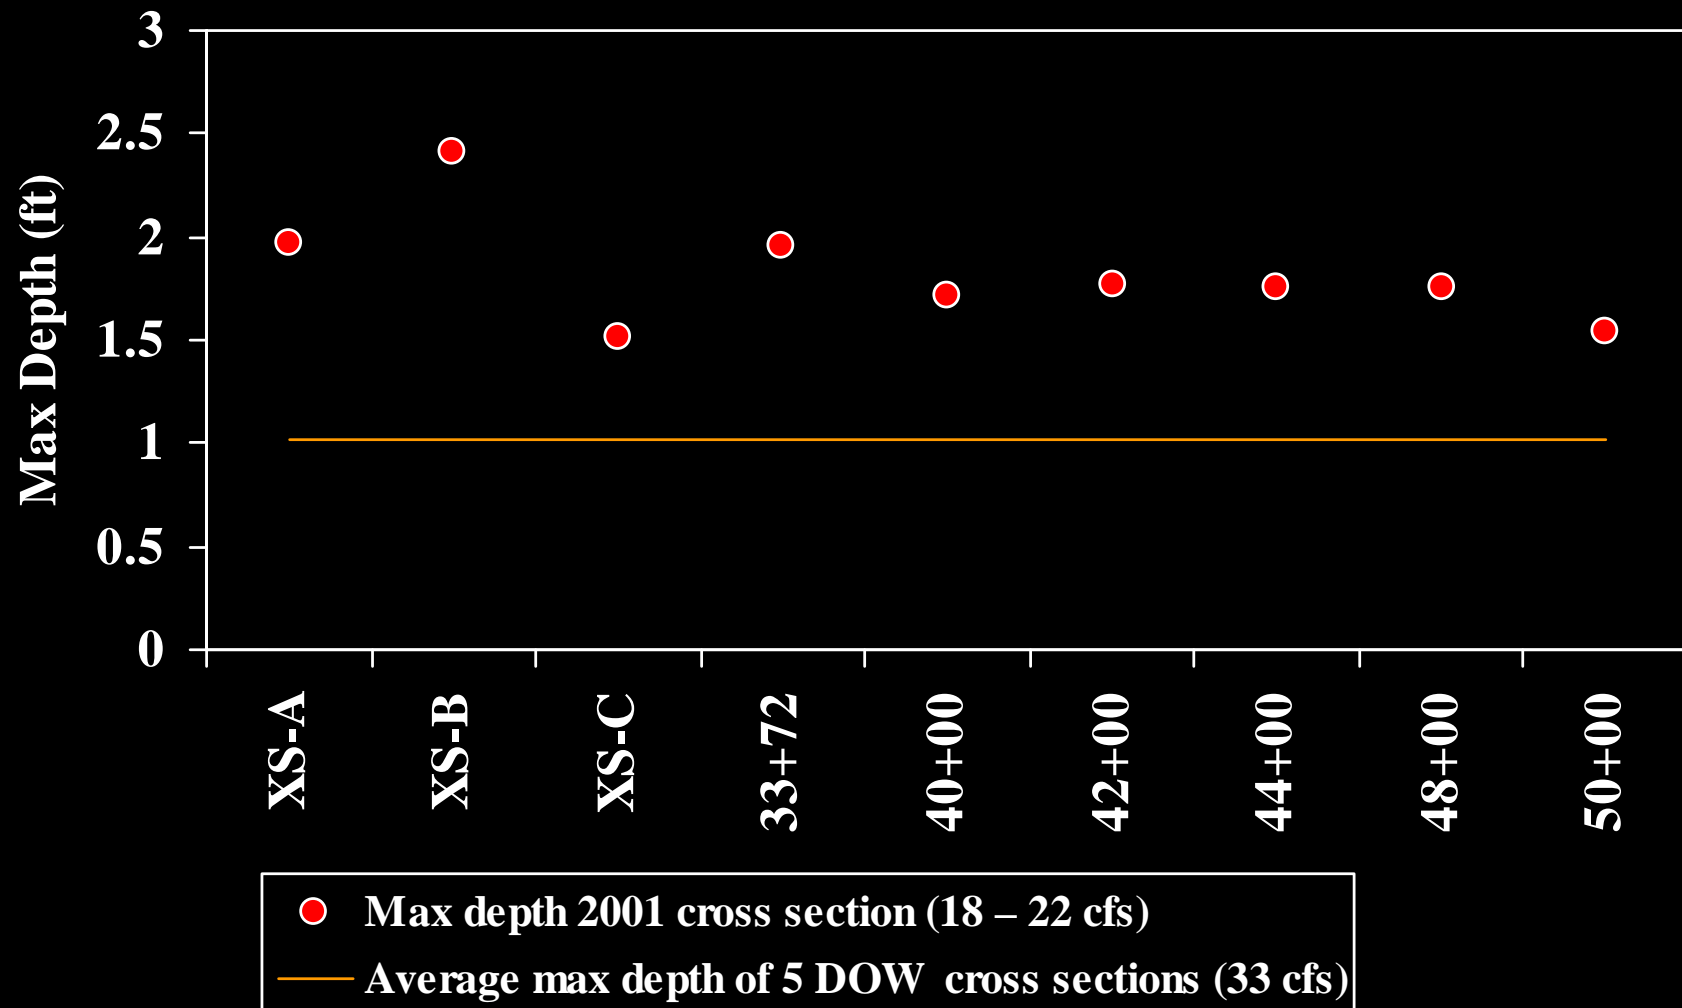
Even with 33 percent less flow, the max depths of the 2001 cross sections are greater than the average max of 5 Division of Wildlife pre-restoration cross sections.

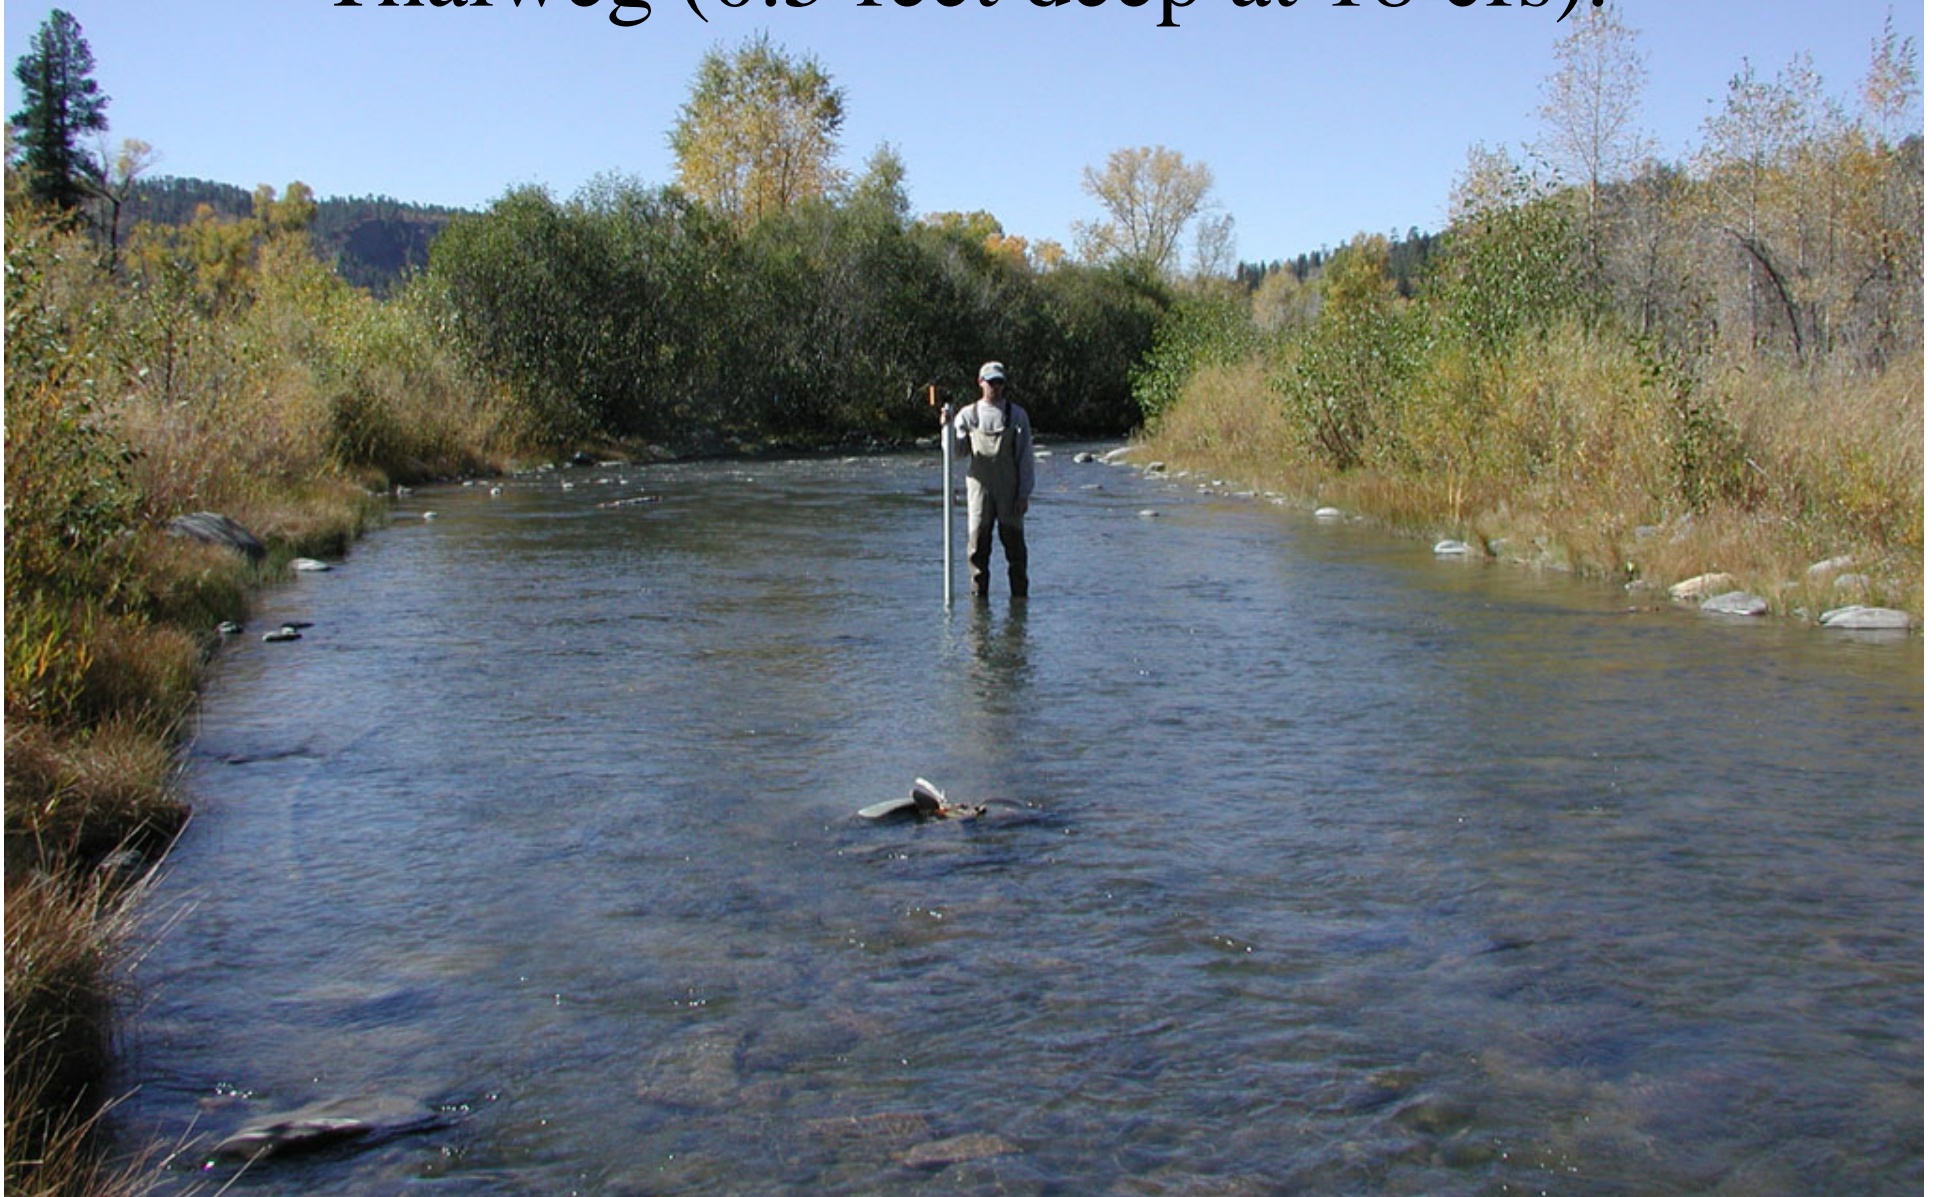
Below the Restored Reach: Poorly Formed
Thalweg (0.5 feet deep at 18 cfs).

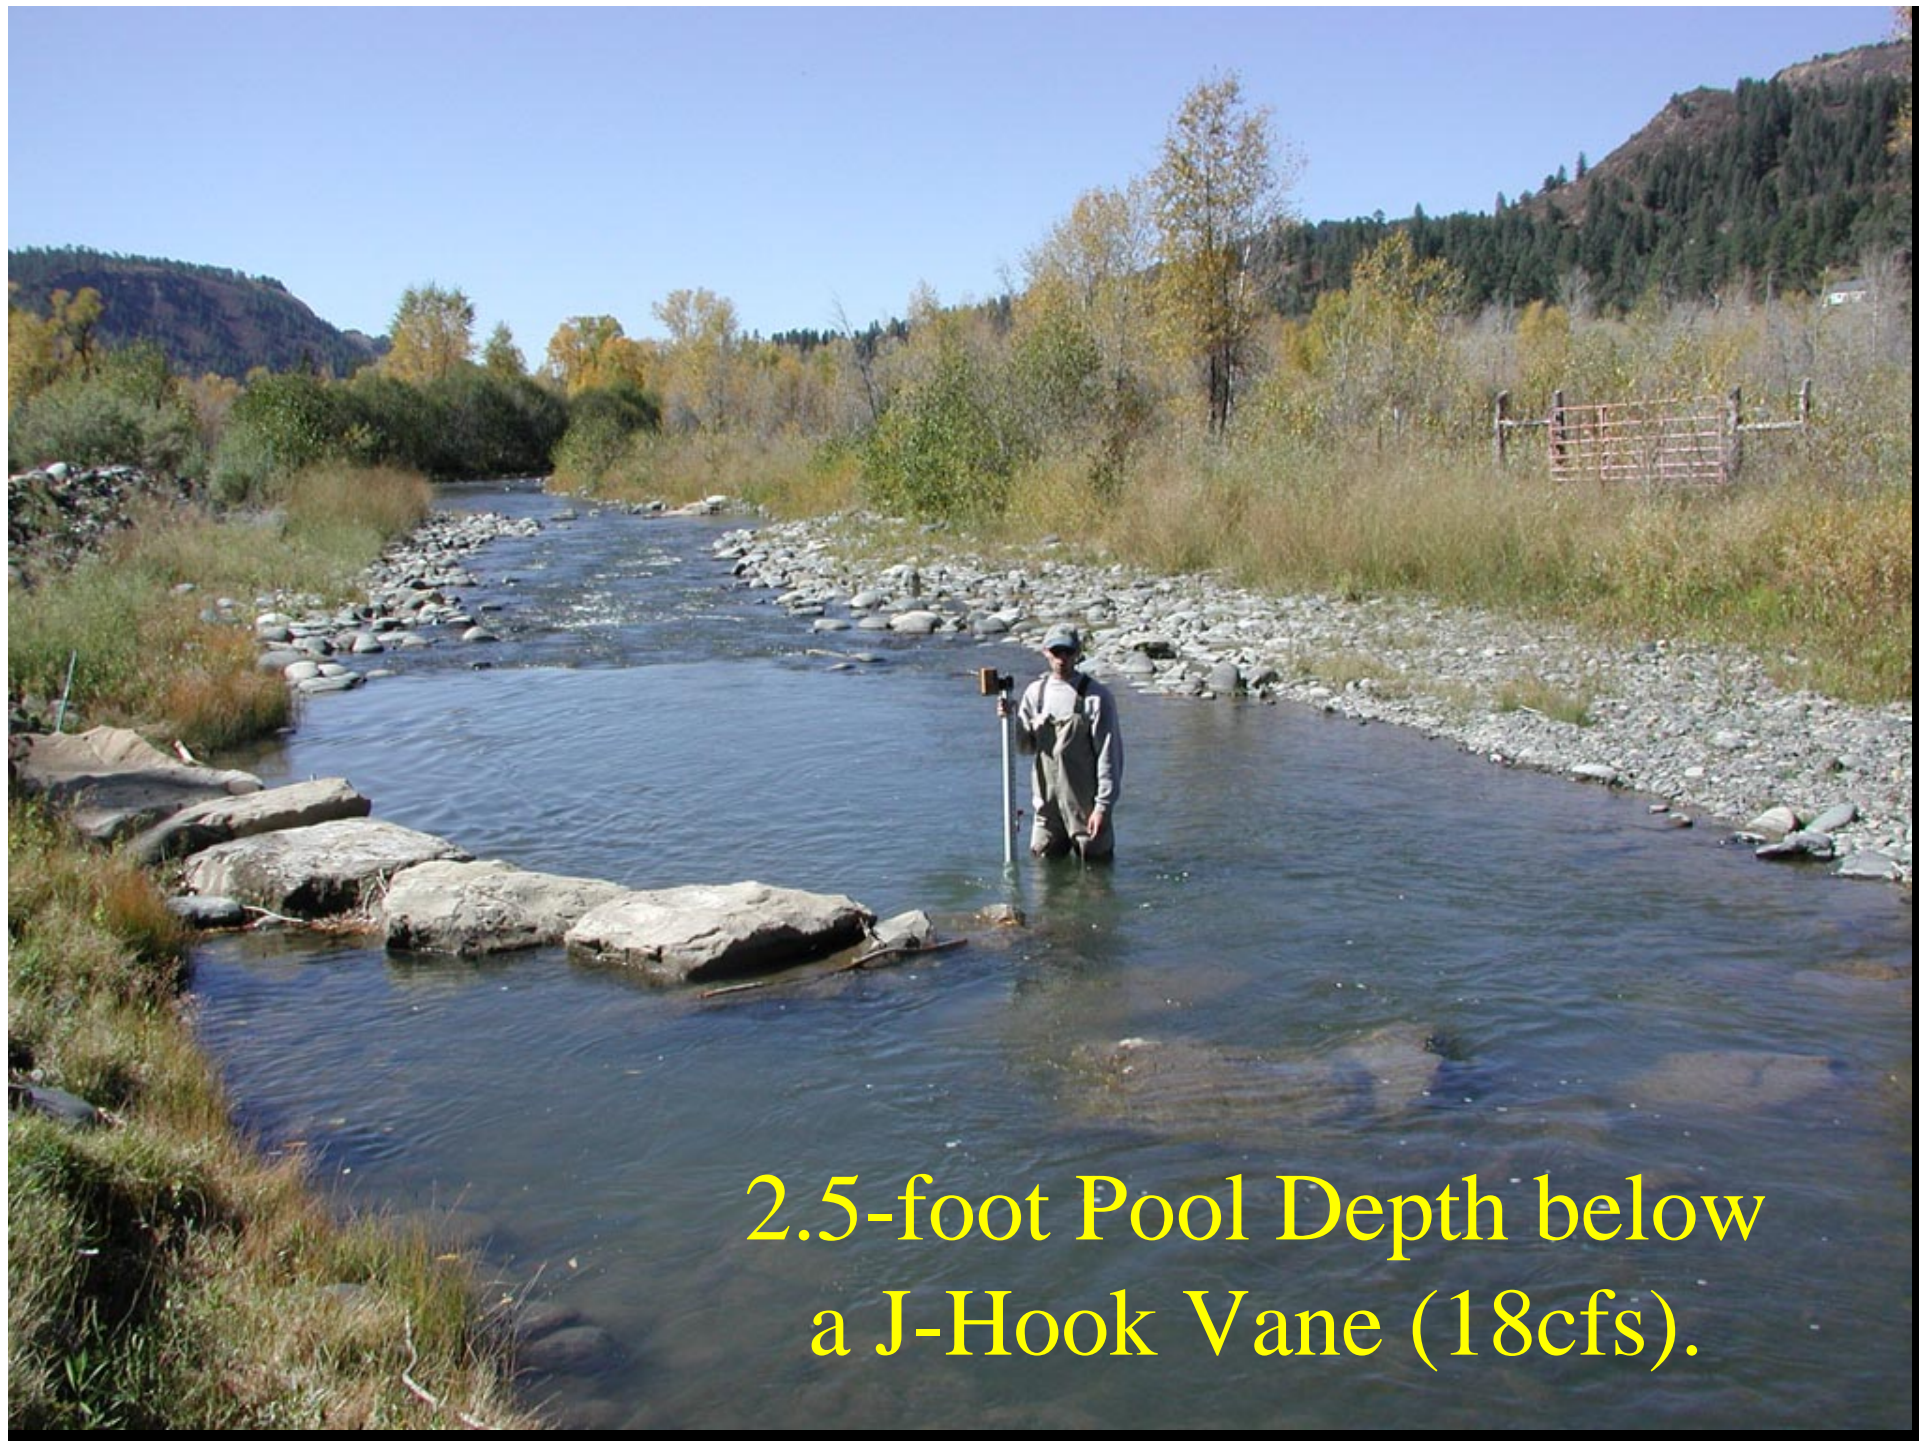
2.5-foot Pool Depth below
a J-Hook Vane (18cfs).

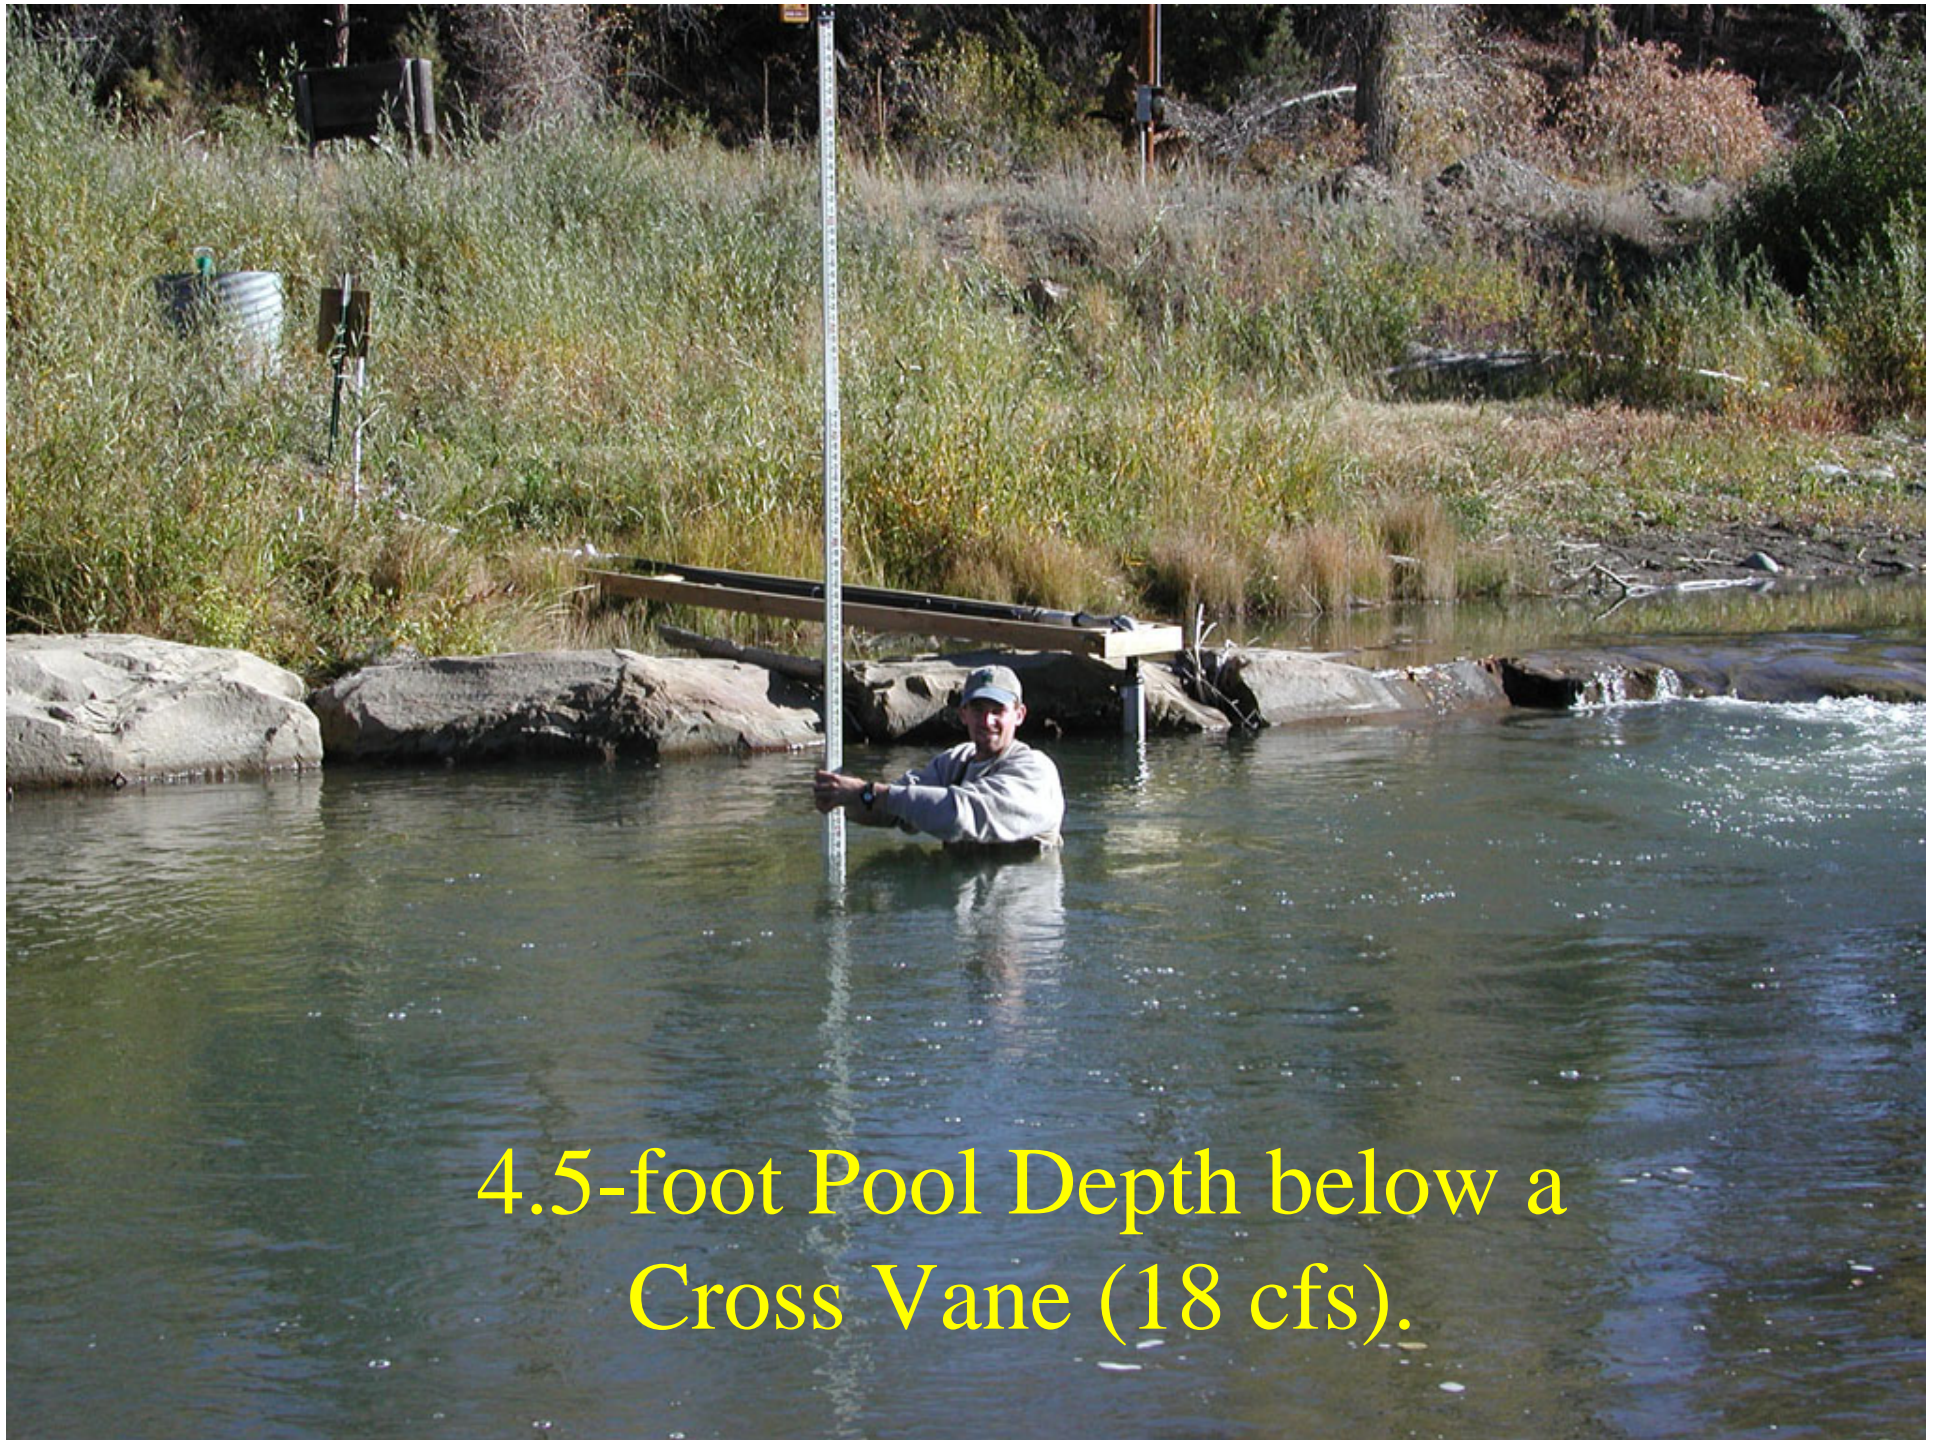
4.5-foot Pool Depth below a
Cross Vane (18 cfs).
