# MONITORING OF THE LITTLE SNAKE RIVER AND TRIBUTARIES

## YEAR 5 - FINAL REPORT

**Monitoring of the  
Little Snake River and Tributaries**

**Year 5 – Final Report**

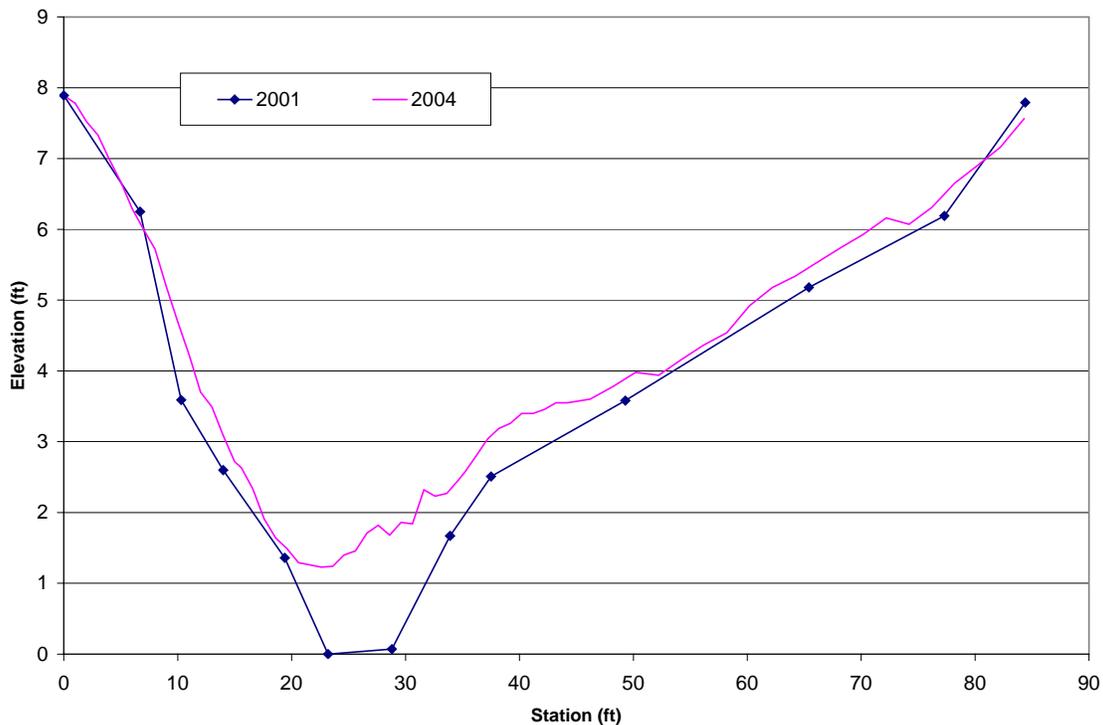
**Figure 6: A representative cross section comparison between 2001 and 2004 surveys indicating aggradation at SF XS6A.**

This trend in aggradation is consistent with the trend identified by the point measurements made at the flow-meter locations. The magnitudes of the adjustments are within the range of variability expected after emplacement of several hundred grade control structures intended to reduce slopes and dissipate energy. Furthermore, the flow conditions between the two surveys would also point towards aggradation. Runoff between 2001 and 2004 includes two historically low-water years

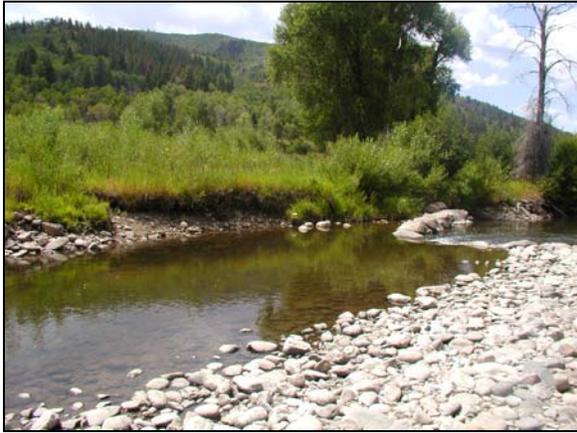
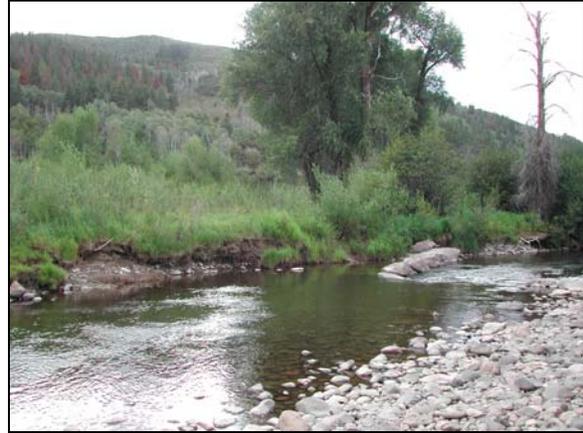
One location was noted in 2004 on the Main Stem upstream of the structure at XS4569 (40° 59.832' N, 107° 03.463' W). The left bank is eroding above the structure, as shown in Figures 28 and 29. This area was revisited in 2005. The bank appears to be slumping due to cantilevering, but dense vegetation on the failure will likely continue to protect it. No action is necessary at this time.

**Figures 28-29: 2004 and 2005 photographs taken of bank erosion on the left bank upstream of the structure at XS4569 (40° 59.832' N, 107° 03.463' W).**

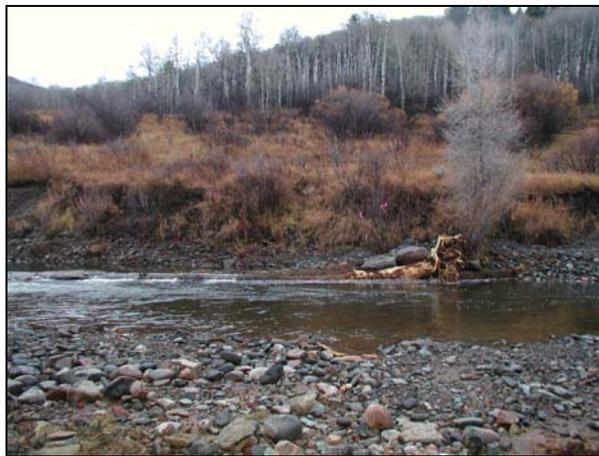
In the Fall of 2005, Wildland Hydrology added a structure at the downstream end of the project (Figure 30). The new structure is a J-hook extending from the left bank composed of log along the leg of the structure reinforced by boulders along the bank and at the tip of the structure.

**Figure 30: Photograph taken on October 20, 2005 of the new structure at the downstream end of the project site.**

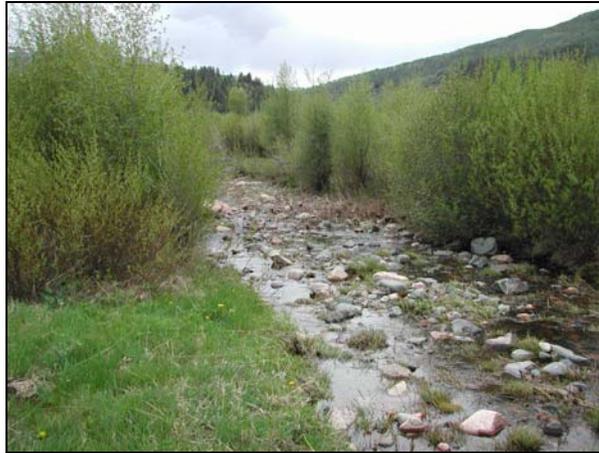
construction. However, the flow did get high enough in 2005 to enter this side channel (Figure 31), but this did not result in any stability problems at the island.

**Figure 31: Flow in the channel behind the North Fork flow-meter island in 2005.**

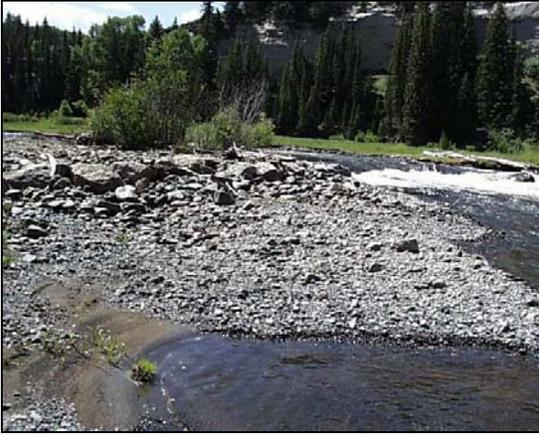
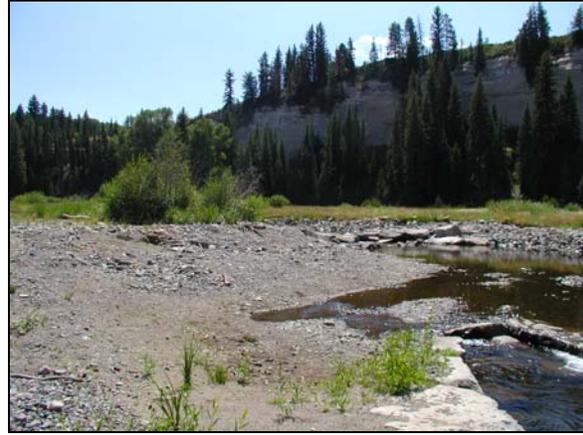
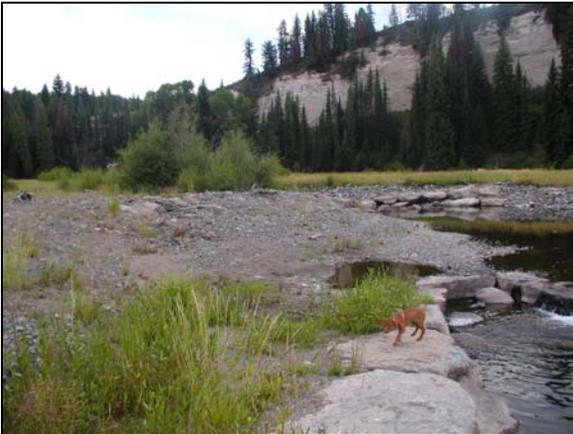
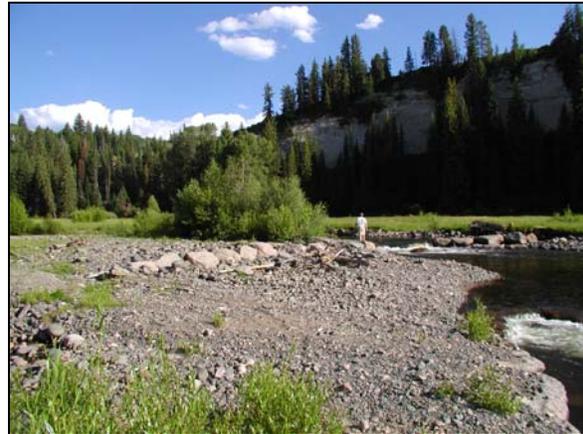
Two locations on the Middle Fork had been targeted for maintenance activities in the past. The first is in the vicinity of the W-weir on the Middle Fork ( $40^{\circ} 59.211' N$ ,  $107^{\circ} 2.283' W$ ) (Figures 32a-d). During high flows in 2003, tie-in rocks of the structure above the W-weir were exposed due to overbank flows and erosion of material covering the right tie-in boulders (Figure 32a). This resulted in downstream deposition of cobbles and gravels in the right side of the W-weir. After recession of the high flows, Three Forks Ranch personnel removed the deposited materials surrounding the W-weir and re-covered the tie-in boulders of the upstream structure (Figure 32b). This location was revisited in 2004 and 2005. Figure 32c shows that the deposition in 2004 is similar to that shown in Figure 32b. Figure 32d shows some uncovering of the tie-in boulders from the high flows in 2005. However, the structure remains stable and no action is required at this time.

**Figures 32a-d: (a) Photograph taken on June 11, 2003, after high flows, showing the exposed tie-in boulders of the structure above the W-weir on the Middle Fork. Note the newly deposited material below the structure. (b) Photograph taken on August 15, 2003, after material removal and re-covering the tie-in rock. (c) Photograph taken on August 16, 2004, showing similar deposition as in (b) ( $40^{\circ} 59.211' N, 107^{\circ} 2.283' W$ ). (d) Photograph taken on July 11, 2005, showing some uncovering of tie-in boulders during 2005 runoff. All photographs are looking upstream.**

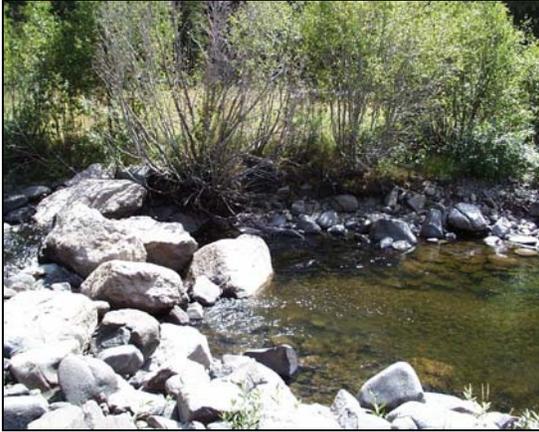
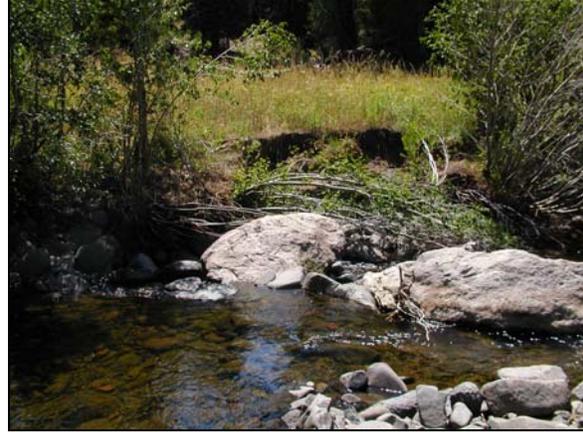
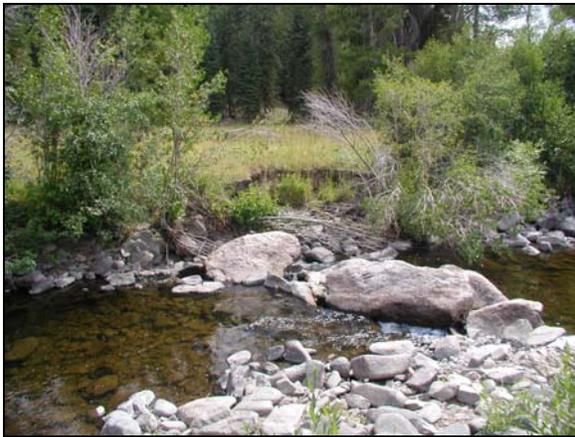
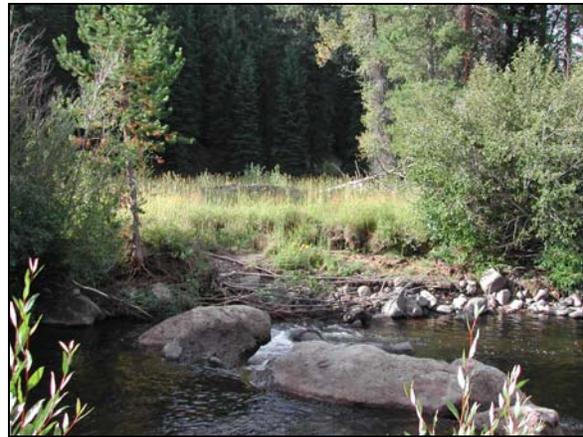
Near the upstream end of the project on the Middle Fork ( $40^{\circ} 59.196' N, 107^{\circ} 2.094' W$ ), the boulders of a structure have shifted into a position that focuses flows on the left bank (Figures 33 through 36). Mass wasting during high flows in 2003 removed an 8-ft section of the willows from the bank. In 2005, the failure is still evident although new vegetation has established on the bank. Filling in this eroded section and emplacing additional boulders or other roughness elements along the bank would improve the stability of this location.

**Figures 33-36: 2002, 2003, 2004, 2005 comparison of the 8-ft section where bank erosion removed willows (40° 59.196' N, 107° 2.094' W).**

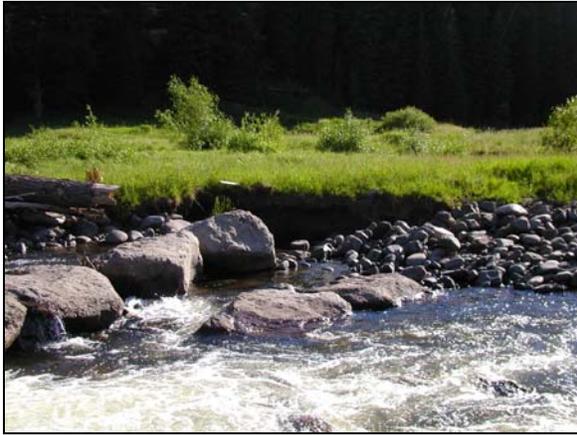
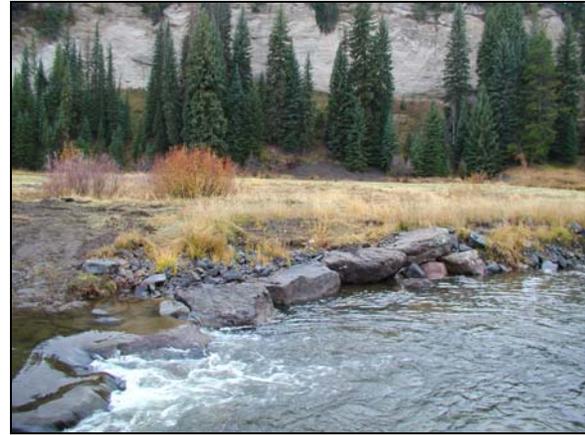
High flows in the spring of 2005 flanked the left side of the structure immediately upstream of the W-weir (Figure 37a). This structure was repaired by Wildland Hydrology in the fall of 2005 (Figure 37b).

**Figures 37a-b: (a) Photograph taken on July 11, 2005, of flanking of the left side of the structure upstream of W-weir. (b) Photograph taken on October 20, 2005, of the same structure after repair.**

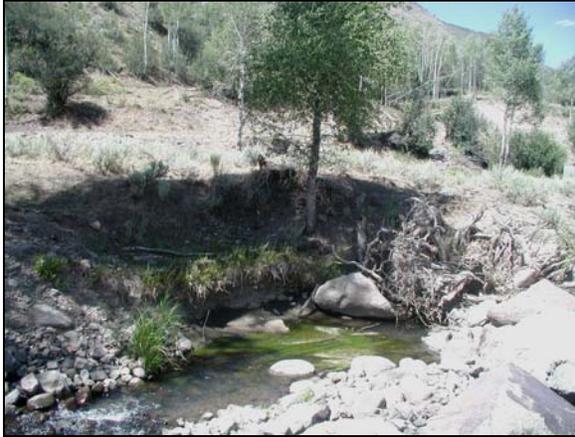
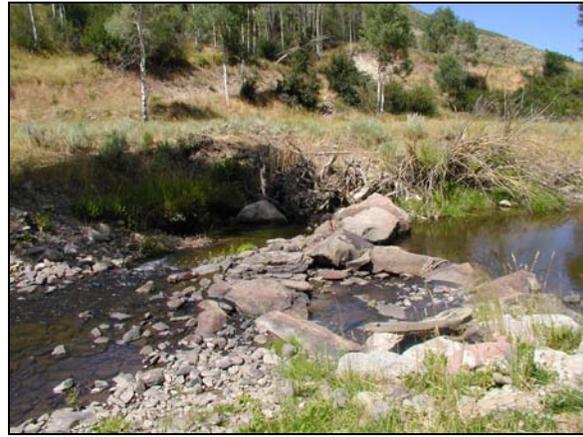
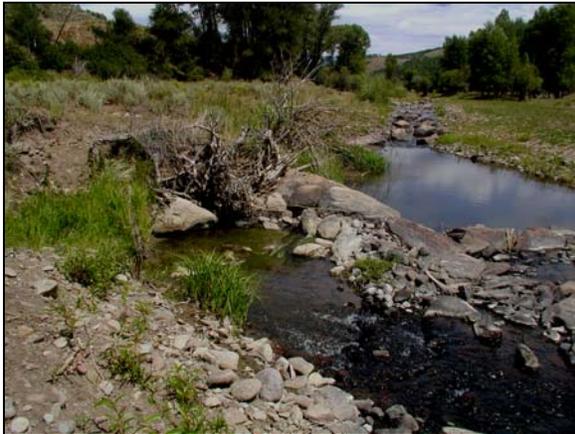
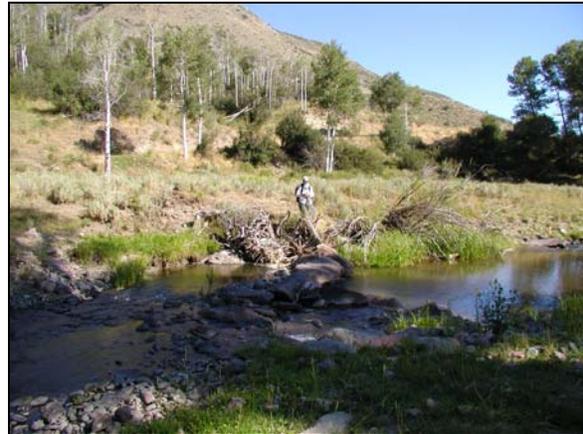
First, at a location identified in 2002 ( $40^{\circ} 56.409' N$ ,  $107^{\circ} 06.042' W$ ), high flows continue to erode the left side of a structure and have removed a small tree from the bank. This erosion is associated with eddying, resulting from flow under the structure at the bank toe. The site remains largely unchanged in 2005, with the exception of some new grasses on the left side of the structure in the failure.

**Figures 38-41: Flow concentrated on the left bank took out small tree on the bank ( $40^{\circ} 56.409' N, 107^{\circ} 06.042' W$ ). The site remains largely unchanged in 2005 (photograph taken on August 17, 2004).**

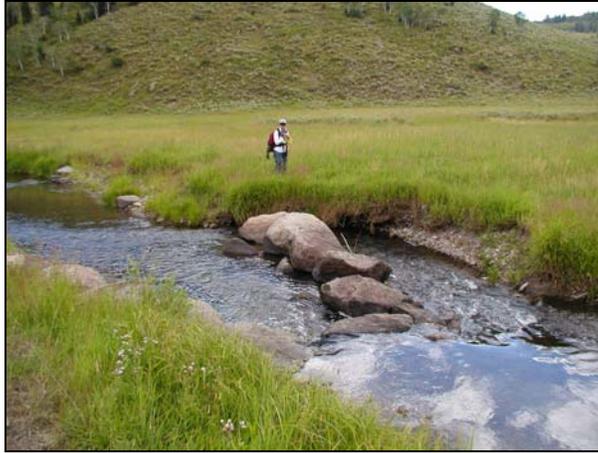
A few other locations along the South Fork exhibit similar erosion characteristics occurring where flow is concentrated on one side of a structure and is beginning to flank the structure. Figure 42 shows a location identified in 2005 where flow is flanking a structure on the right bank ( $40^{\circ} 58.327' N, 107^{\circ} 03.151' W$ ).

**Figure 42: Photograph taken on August 23, 2005, showing a South Fork structure flanked on the right bank ( $40^{\circ} 58.327' N$ ,  $107^{\circ} 03.151' W$ ).**

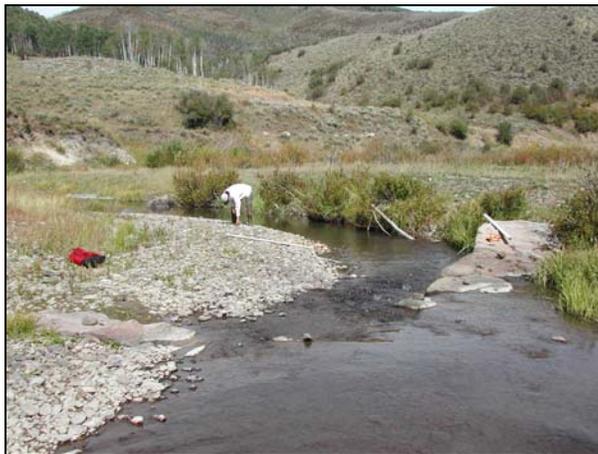
There are numerous locations along the South Fork where a point bar on the inside of a bend has migrated toward the channel centerline and resulted in filling of structures and thalweg shifts toward the outside of the bend (Figure 43). This results in greater shear stresses but has not resulted in substantial amounts of bank erosion due to vegetation established along the banks.

**Figure 43: J-hook structure on the South Fork filling in by a point bar on the left bank opposite the tie-in ( $40^{\circ} 57.203' N$ ,  $107^{\circ} 05.163' W$ ).**
