**STREAM CLASSIFICATION, STREAMBANK EROSION
AND FLUVIAL INTERPRETATIONS FOR THE
LAMAR RIVER AND MAIN TRIBUTARIES**

**USDI NATIONAL PARK SERVICE
YELLOWSTONE NATIONAL PARK**

**DAVID L. ROSGEN, P.H.
WILDLAND HYDROLOGY
PAGOSA SPRINGS, COLORADO**

JULY 17, 1993

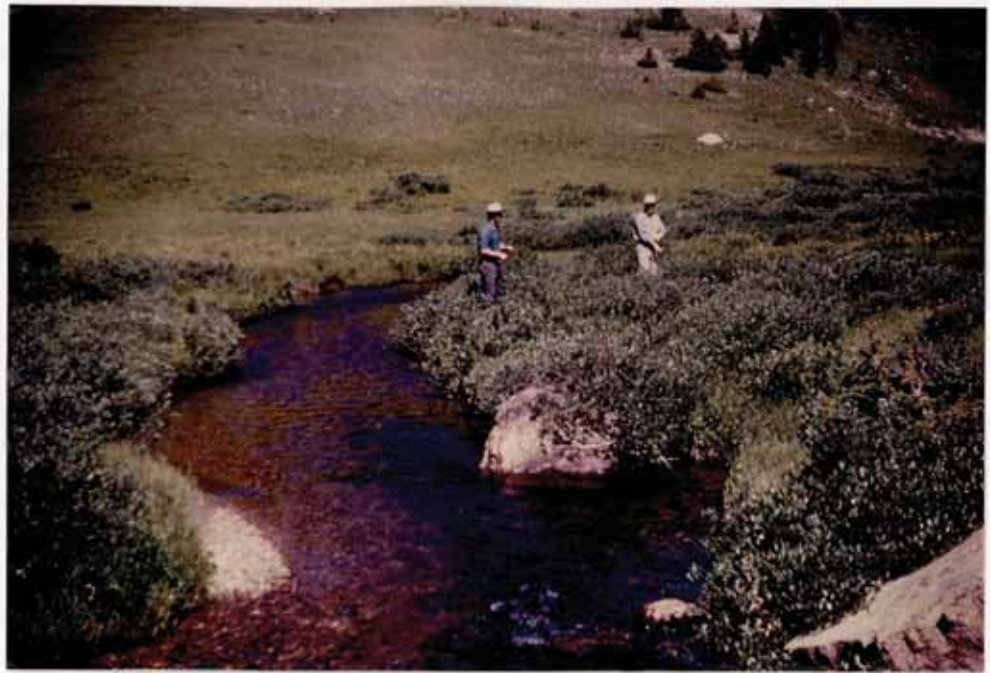
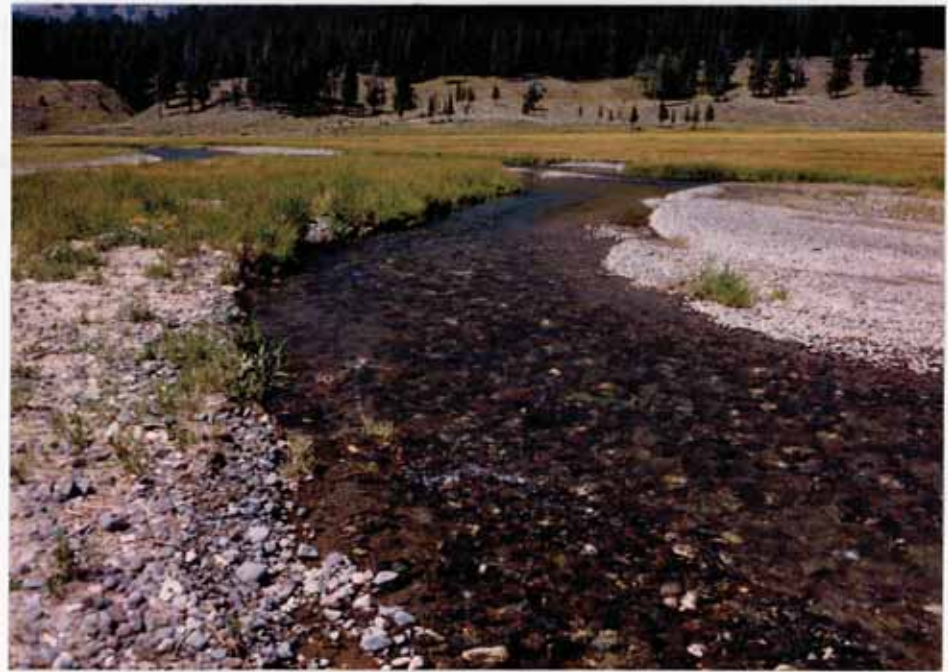
Figure 8. Comparison of streambank erodibility (low vs high erodibility) for C4 stream types. (lower photo is lower Soda Butte Creek).

Examples of streams with low vs high bank erodibility potential for the same stream type is shown in Figure 8. Erosion rates should be less in the top photo with the lower streambank erodibility rating. The width/depth ratio and extent of bar deposition also shows a marked contrast between the "state" or condition of these two C4 stream types.

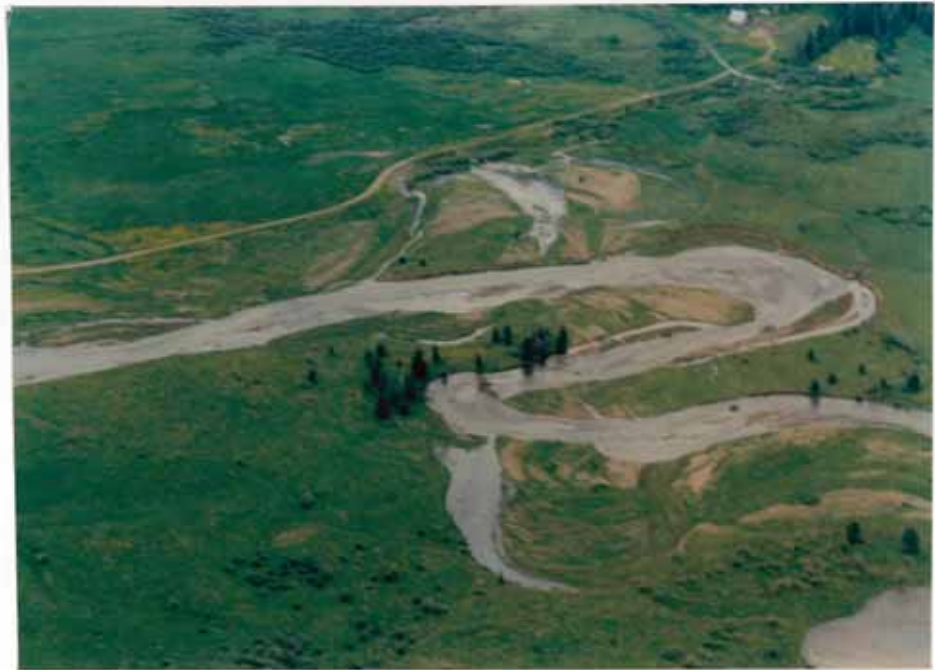
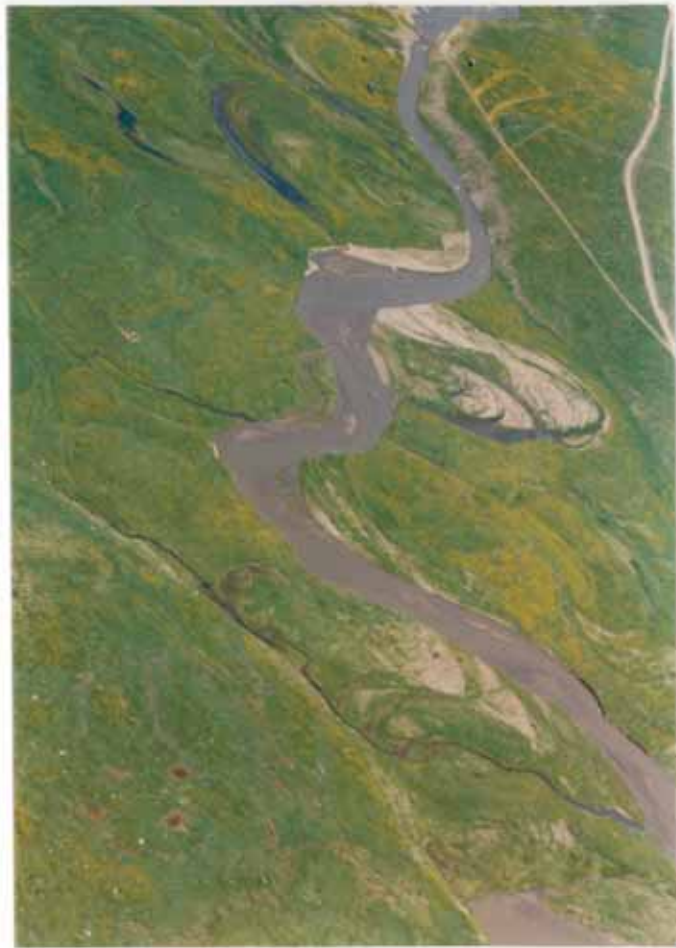
Figure 13. Weminuche River in Colorado (C4 stream type) showing change in channel stability, pattern, dimension, and bank erosion due to a willow/grass conversion.

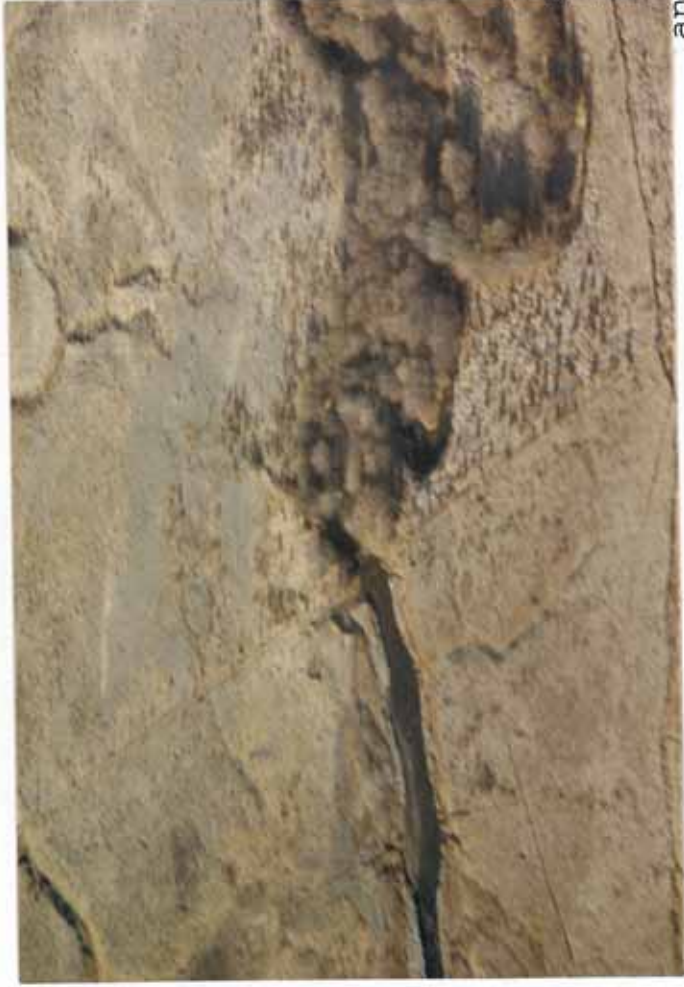
← Figure 14.

Contrast of late fall/winter grazing-heavy stocking on C4 stream type showing conversion to a grass/forb riparian community from a willow/grass community

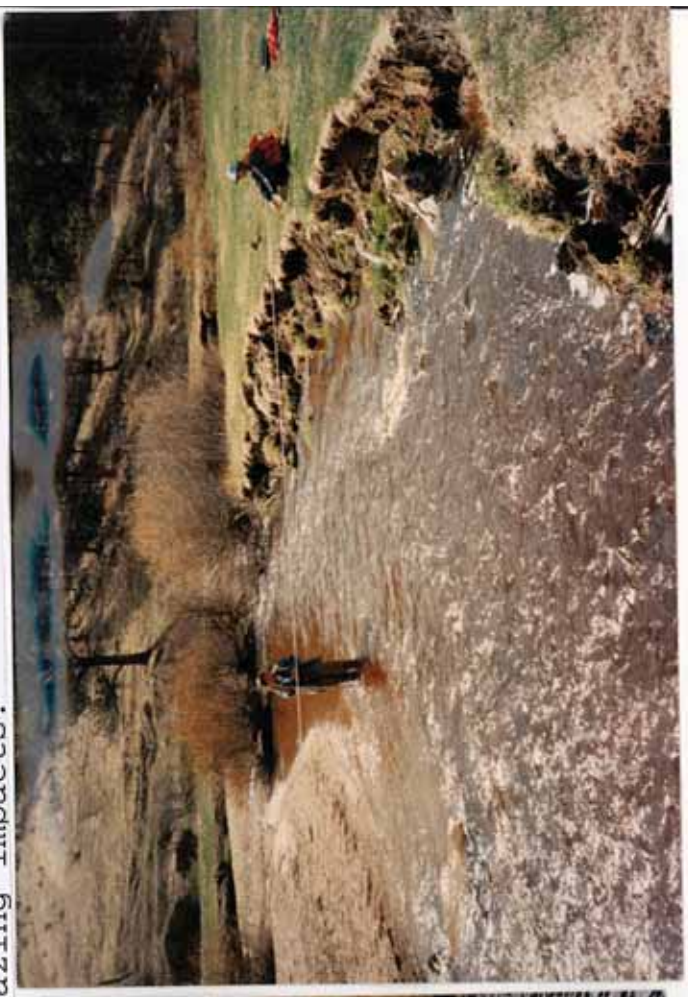
Figure 15. ↓

pose Creek, Colorado, upstream (lower left photo) and 900 feet downstream (below) on C4 stream type showing effects on bank stability and channel shape due to willow conversion from grazing impacts.

Since streambank vegetation is very sensitive to streambank erosion, changes in vegetative composition can have a marked effect on bank erosion/sedimentation rates. Grazing/browsing impacts, especially in late fall/winter seasons has caused removal of willows from many western ranges. The conversion shown with the fence line contrast of late-season grazing by livestock eliminated willows from this C4 stream type. The willow pasture is grazed (see trails) but not late and with a lower stocking rate (Figure 14) This meadow is in South-Central Colorado at 7200 feet elevation. Another example of willow/grass conversion is at a detailed study site on Goose Creek in South-Central Colorado (tributary to the South Platte River). The lower left photograph (Figure 15) shows the streambank/stability conditions 900 feet upstream on the same stream and same C4 stream type of the lower right photo. Two different grazing strategies of season/intensity of uses created a vegetation conversion of Willow to grass. The resultant erosion rates for the upper vs lower reach were .03 vs 3.0 feet/year respectively.

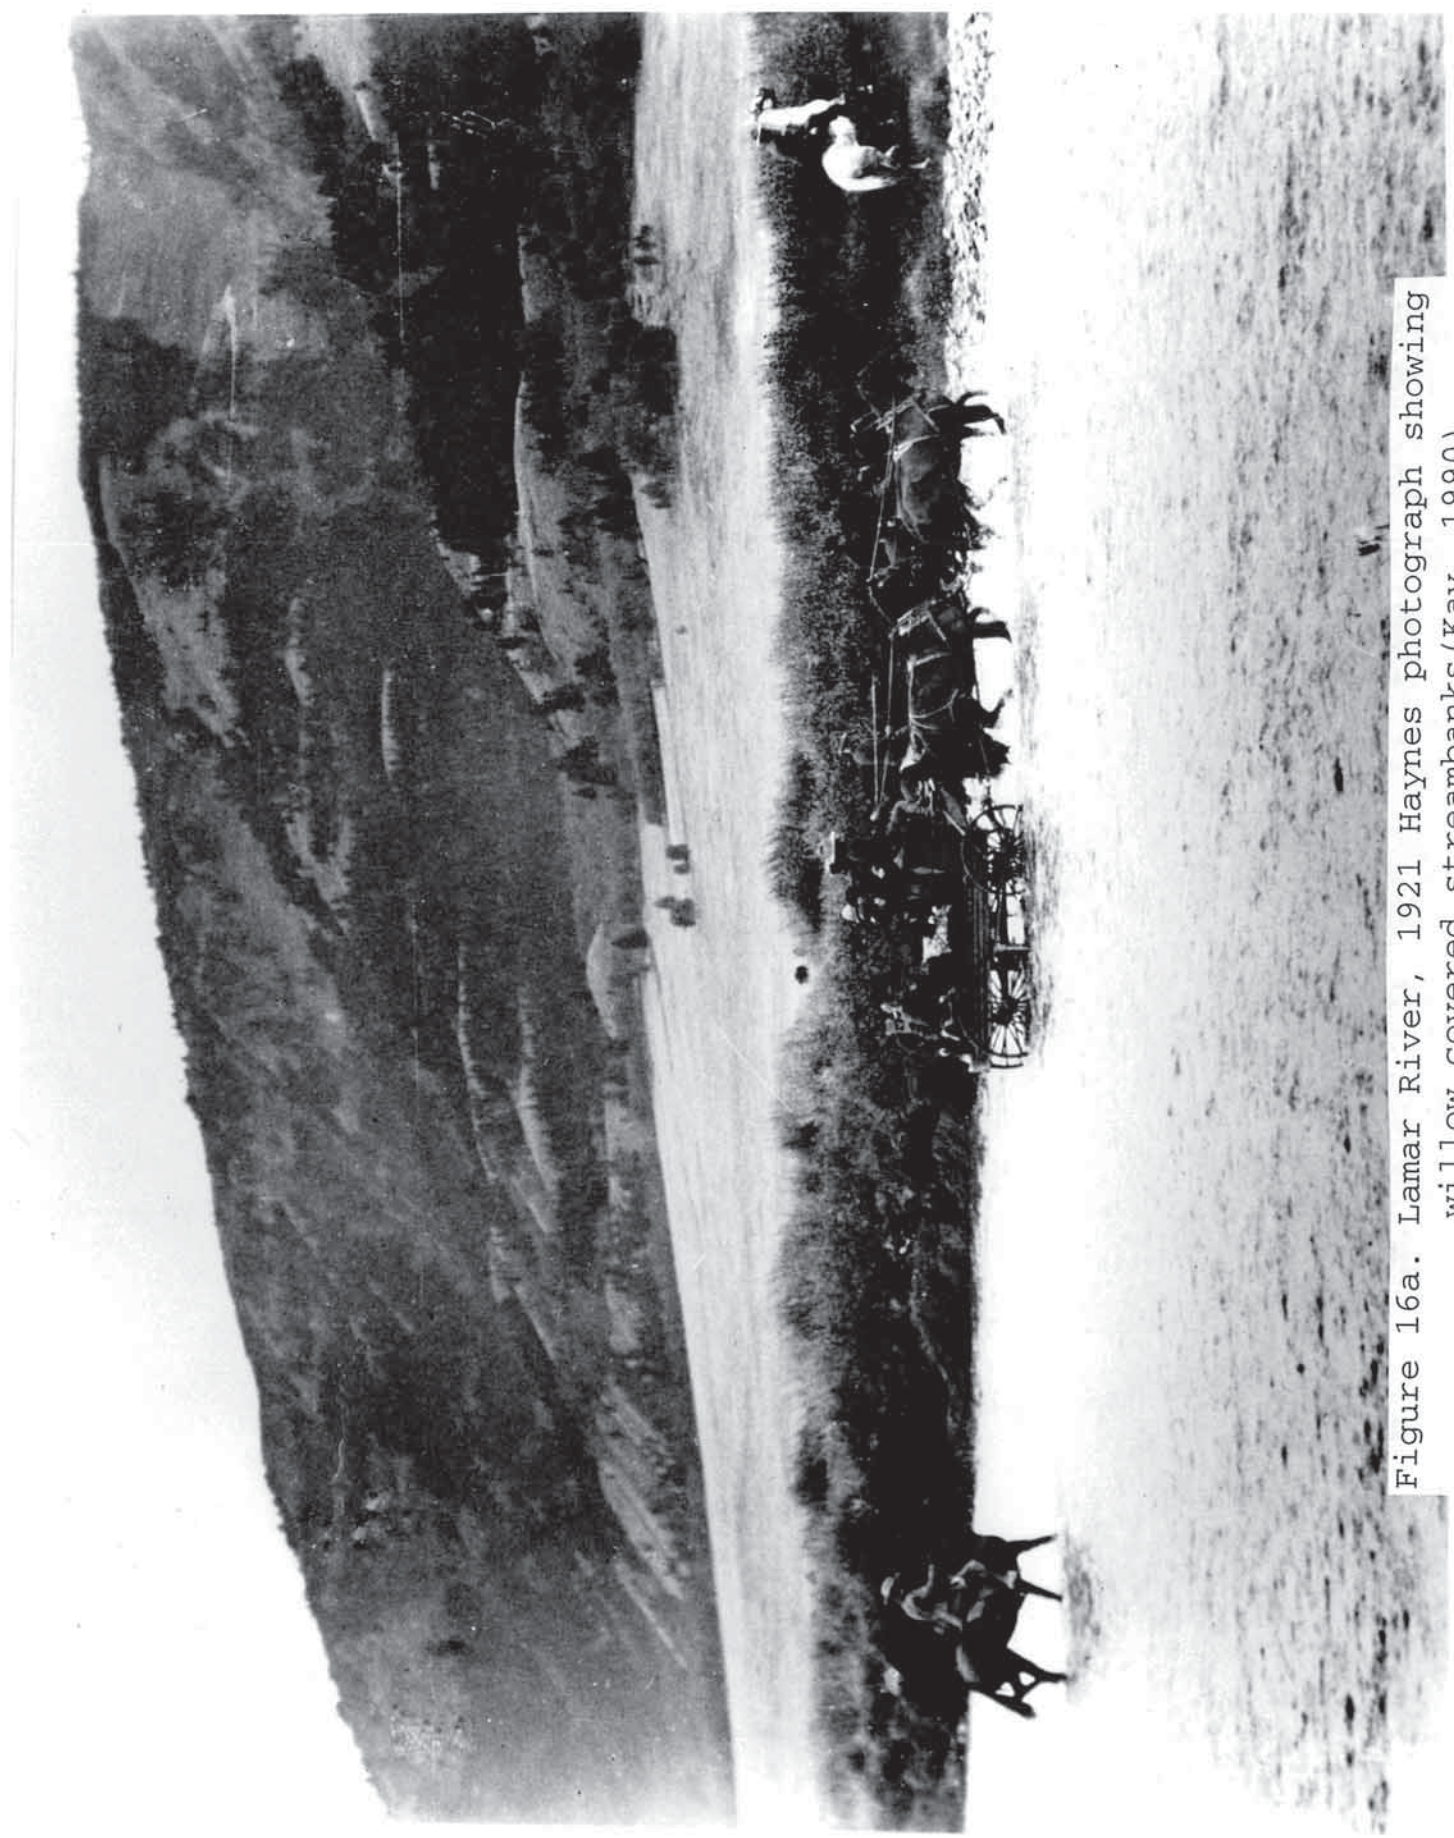
Figure 16a. Lamar River, 1921 Haynes photograph showing willow covered streambanks (Kay, 1990)

Similar results of vegetative conversions from willow/grass to grass/forb communities due to browsing ungulates have been reported by research in Yellowstone National Park (Kay and Chaddle, 1991), (Kay, 1990), (Putman and others 1989), and (Risenhoover and Maass, 1987). Large herds of elk did not inhabit the Greater Yellowstone Ecosystem until the late 1800's (Wright 1984), and evidence of elk browsing on willows was not evident on photographs from 1870-90 (Kay 1990). Thus, conversion of willows to grass communities due to heavy late-season/winter browsing on the Lamar River and many of its tributaries has changed bank erodibility potential and associated bank erosion rates as presented earlier. The replicate photographs (Kay, 1990) shown in Figures 16a-18b depict this dramatic conversion.

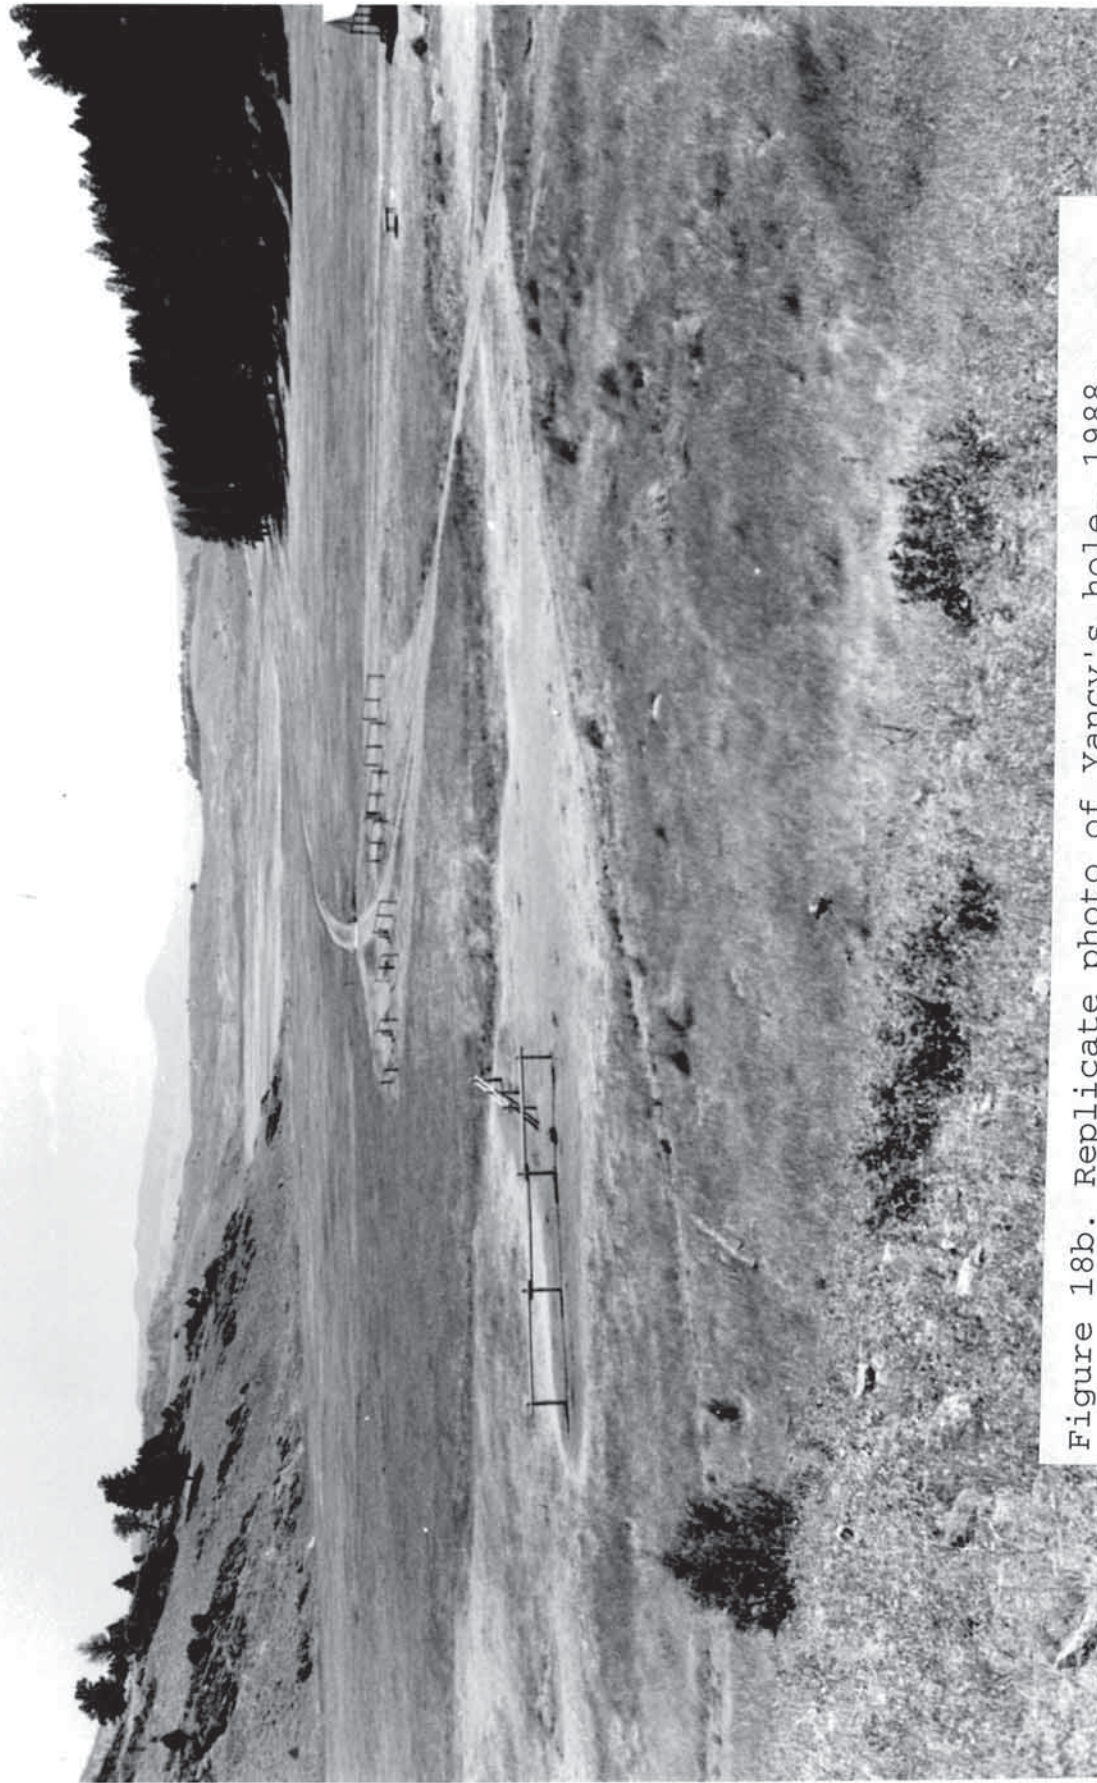
Figure 18b. Replicate photo of Yancy's hole, 1988, showing loss of willows from stand (Kay, 1990).

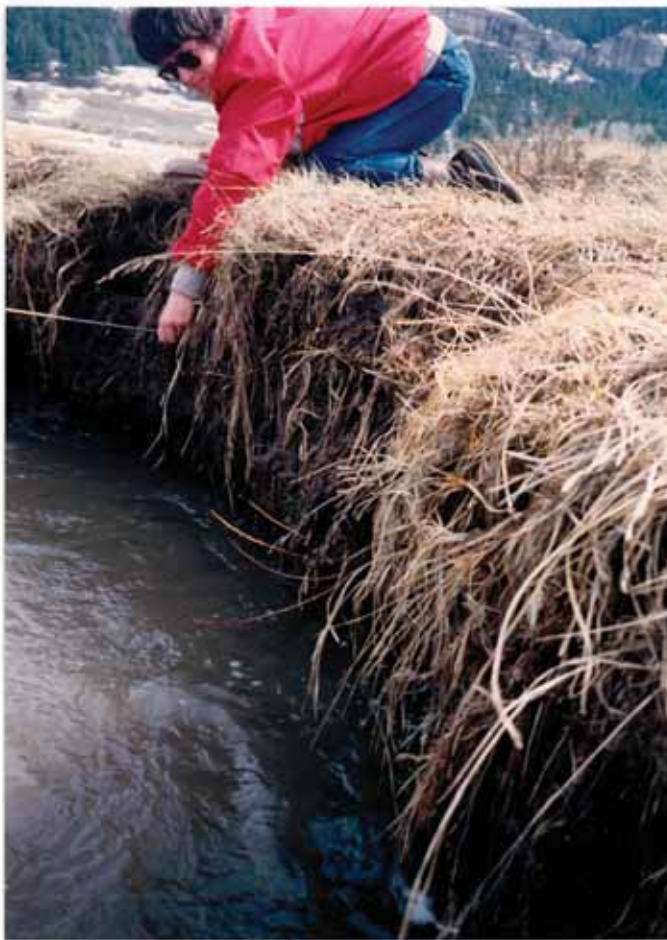
Figure 20. Soda Butte Creek site #1, bank erodibility BEH: Very high, Stress: high, Bank erosion rate: lost 3 ft. pin.

The results of the bank erosion pins, bank erodibility and stress in the near-bank region are very similar to work done for the Forest Service in Colorado. Some of the actual erosion rates during a "normal" runoff season in 1989/1990 exceeded the expected rate by eroding out the entire 3.0-4.0 foot erosion pins. For example on Soda Butte Creek near the footbridge, (SBR-1), with a very high bank erodibility and high stress, a 3.0 foot erosion pin was lost, thus rates were greater than 3.0 feet (Figure 20).

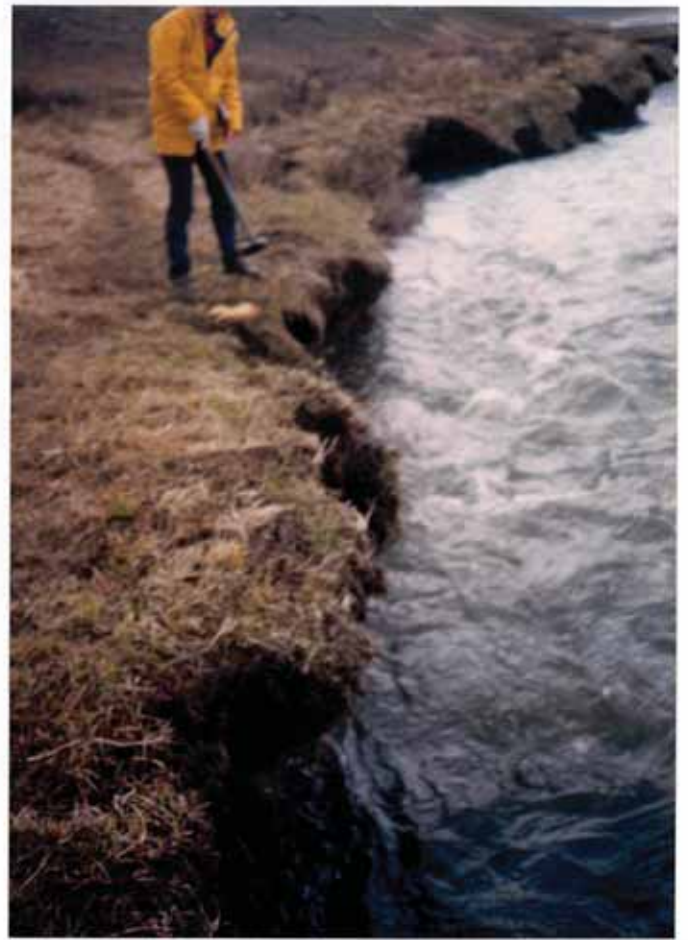
Figure 21. Soda Butte Creek, Site #2 BEH:Very High, Stress: Very High. Bank erosion rate:, lost 3 foot erosion pin.

Streambank erosion rates for Soda Butte Creek #2 based on Bank erodibility-very high, stress-high...lost 3 ft. pin (Figure 21). Soda Butte # 5 also had no willows on bank...results: bank erodibility-very high, stress-high...lost a 3 ft. erosion pin (Figure 22). A major contrast of streambank erodibility potentials shown with and without willows for the same stream type in the same river (Figure 23). Results of bank erosion rates on Soda Butte Creek #7 where bank erodibility-extreme, but stress was moderate +. Bank erosion rate was 1.2 feet/year (Figure 24). On a reach where willows were present on Soda Butte # 12, the erodibility potential rating was low, and stress was moderate. The erosion rate was 0.1 ft./yr. (Figure 25).

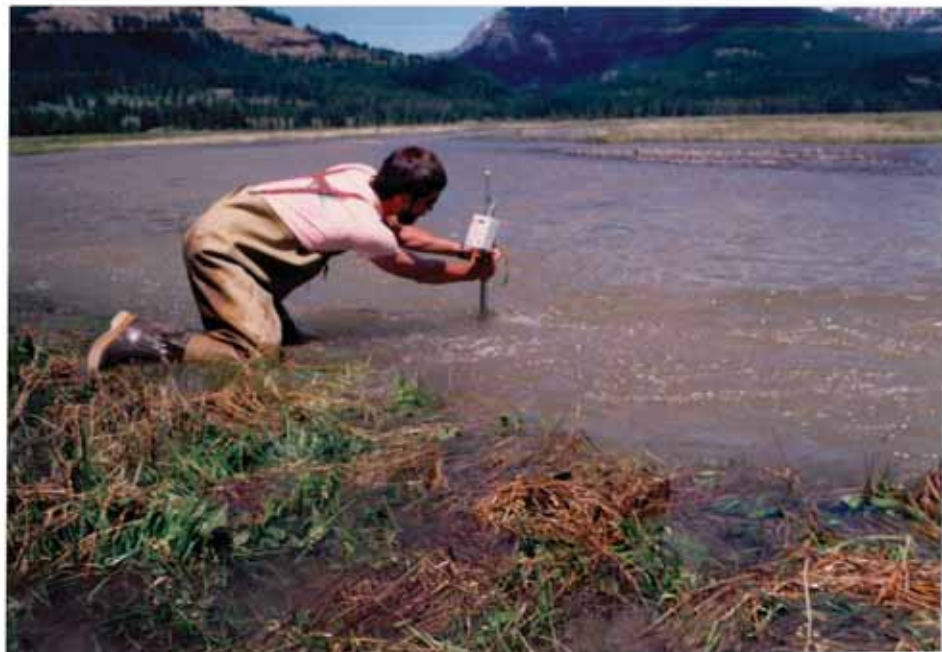
Figure 22. Soda Butte Creek # 5, BEH: Very High, Stress: High, Bank erosion rate:, lost 3 foot pin.

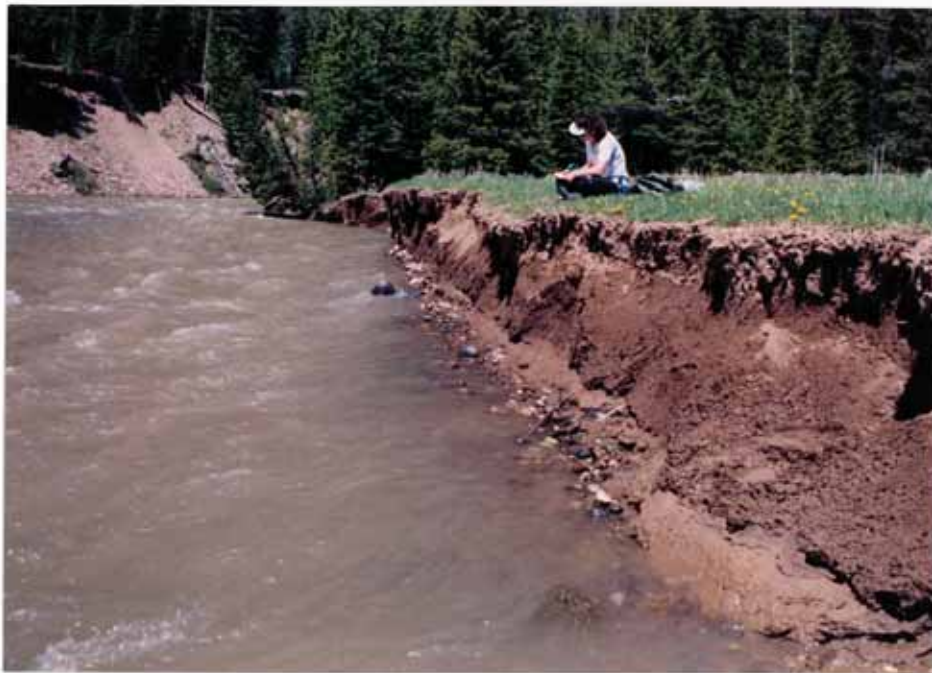
Figure 24. Soda Butte Creek #7, BEH: extreme, Stress: moderate + erosion rate: 1.2 feet/ year.

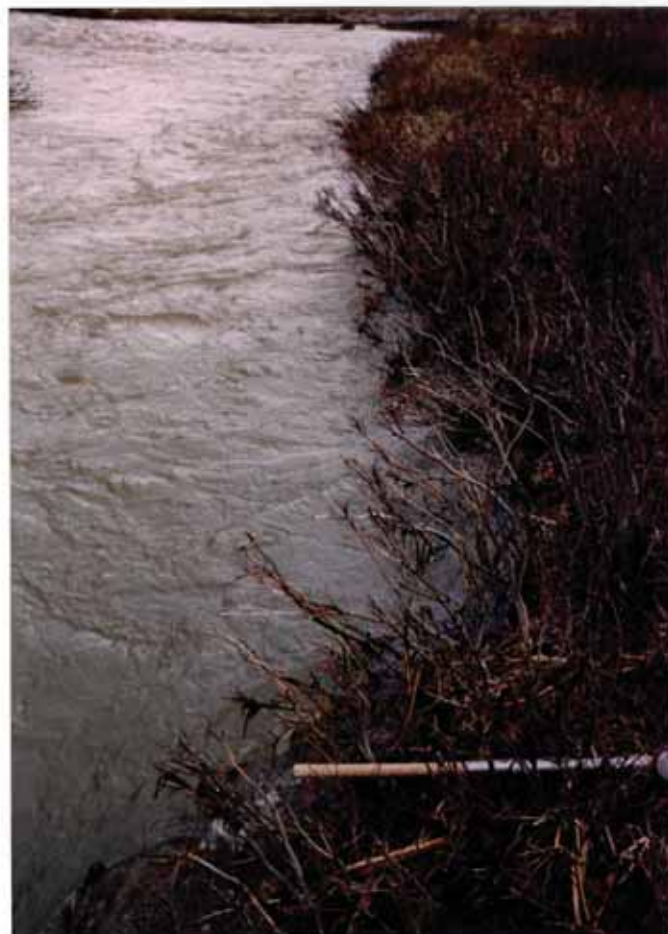
Figure 25. Upper Soda Butte Creek # 12 with willow bank. BEH: low, stress: moderate, bank erosion rate 0.1 ft./yr.

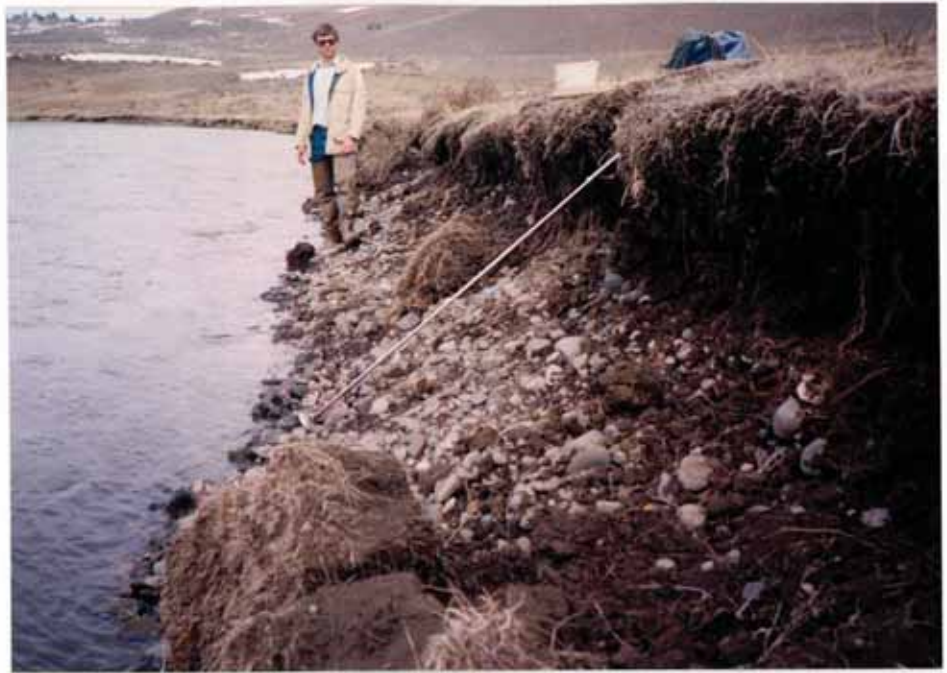
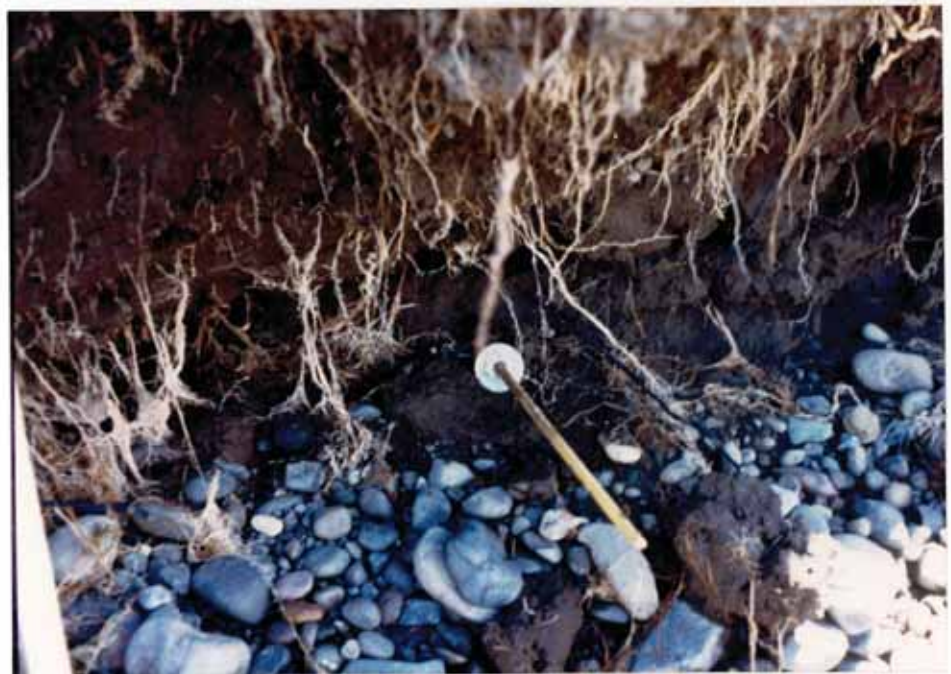
Figure 26. Lamar River # 1, BEH: Very high, Stress: Low, Erosion rate: 0.78 feet/year (note: exposed erosion pin).

Bank erosion rates on the lower reaches of the Lamar River at station # 1, which had a bank erodibility of very high, but low stress, yielded an erosion rate of

0.78 ft./year (Figure 26). Data from the lower Lamar River at station #2 with a bank erodibility rating of very high and a stress of high had an erosion rate of 2.1 ft./yr. (upper pin), and 0.9 ft./yr. (lower pin), with an average rate of 1.5 feet/yr. (Figure 27). Another erosion study site on the Lamar River (#5) for a bank erodibility rating of very high, but a stress of low, yield an erosion rate of 0.76 (Figure 28). There is considerable more data, thus the data is summarized and statistically analyzed similarly to the data set of the U S Forest Service (Figure 29). An analysis of variance was conducted on this data set and the coefficient of determination, (R^2) of 0.87 was obtained. This was highly significant at the 95 per confidence level.

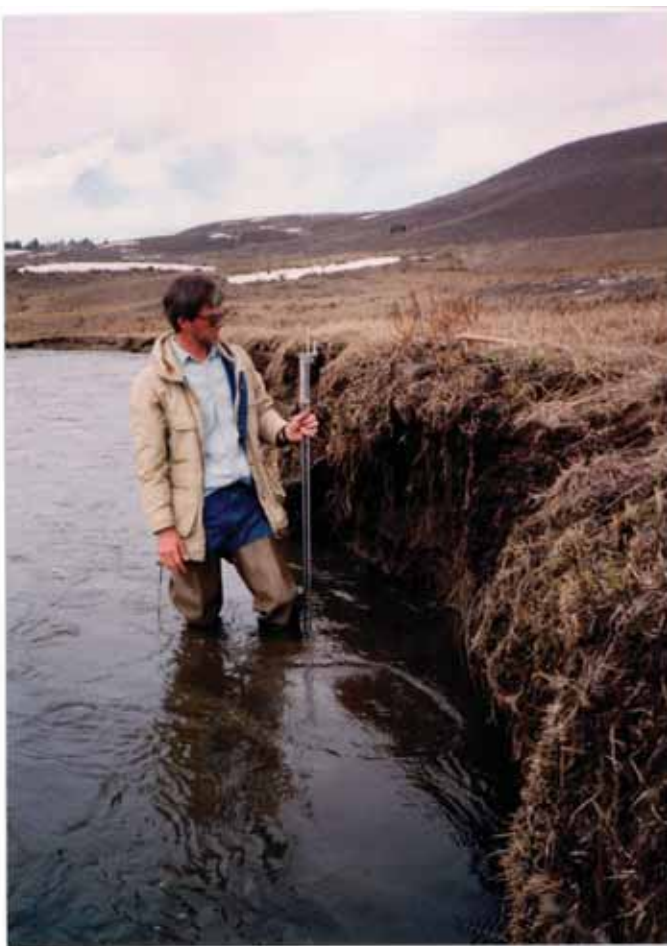
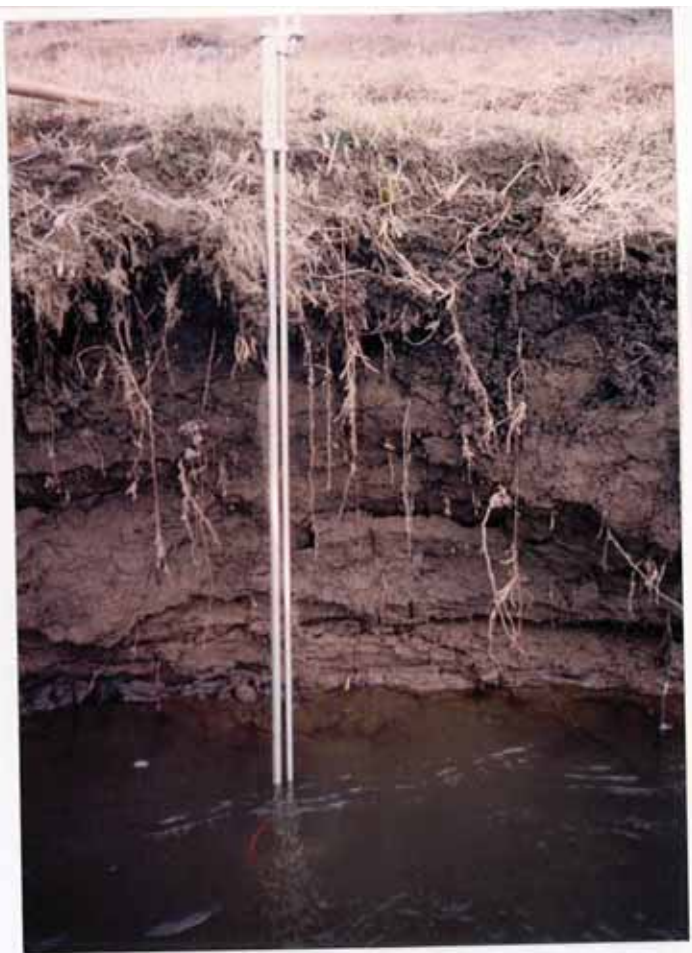
Figure 27. Roy Ewing, NPS, at lower Lamar River site #2 with BEH: Very High, Stress: High, Erosion rate: 2.0/0.9, ave.: 1.5 ft./yr.

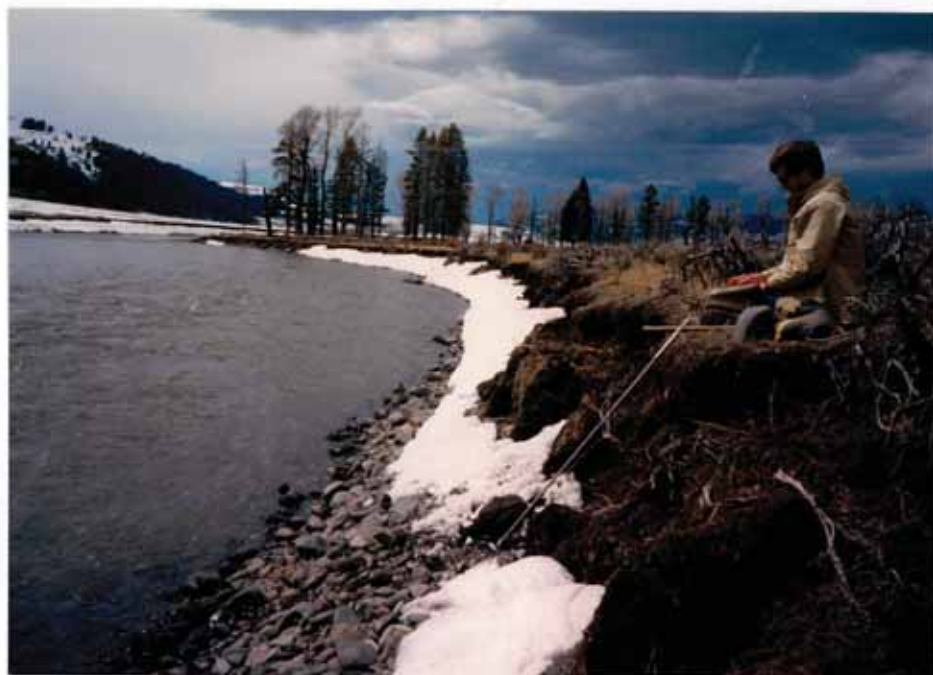
Figure 28. Lower Lamar River #5 Beh: Very High, Stress: Low, Bank erosion rate: 0.76 ft./yr.
