# MONITORING OF THE LITTLE SNAKE RIVER AND TRIBUTARIES

## YEAR 5 - FINAL REPORT

**Monitoring of the  
Little Snake River and Tributaries**

**Year 5 – Final Report**

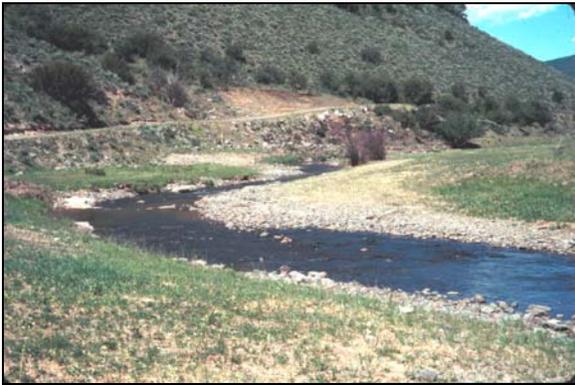
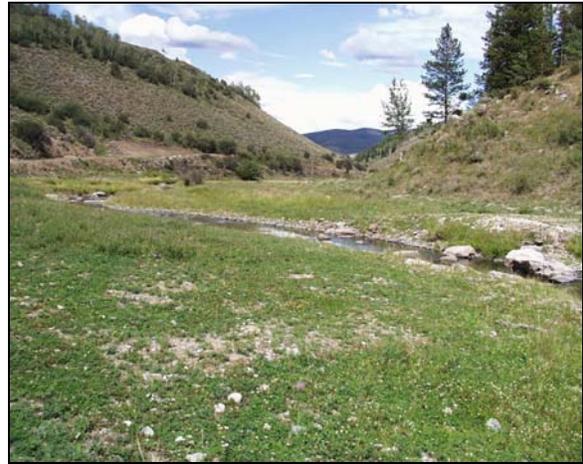
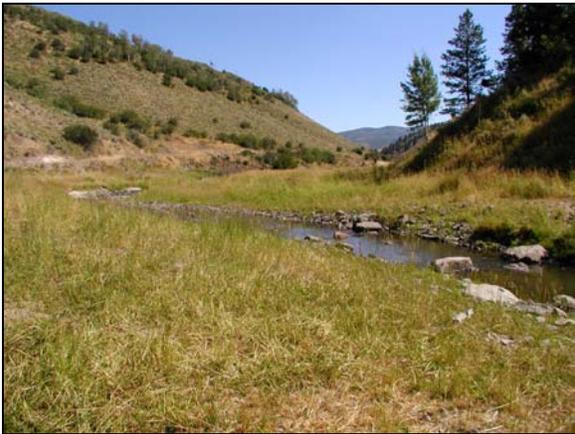
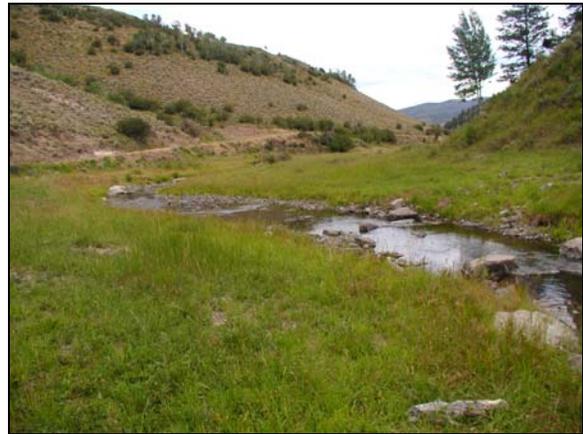
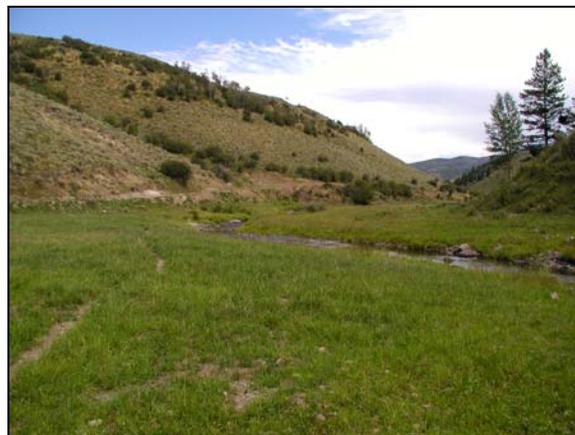
**Figures 7-11: Sequence of vegetation establishment along the South Fork (photo-point SFPP18, looking downstream).**

Photo points located throughout the project provide a means to observe changes in vegetation over time. Figures 7 through 11 depict a representative progression of vegetation colonization along a cobble bar of the South Fork of the Little Snake, while Figures 12 through 16 depict a similar representative progression along the Main Stem. Although this vegetation establishment is encouraging, it is not limited to reaches within the project. At an additional photo point located downstream of the end of the project, similar colonization is occurring (see Figures 17 through 21). This could be related to upstream restoration activities, or could be an indicator that vegetative changes are partially due to climatic factors. Vegetation colonization in lower levels of the channel may reflect successive low-flow years during the drought cycle. Vegetation has thrived throughout the restoration project since construction, despite drought conditions. Much of this improvement is attributable to improved grazing practices and enhanced hydrologic connectivity of the riparian corridor resulting from the restoration project.

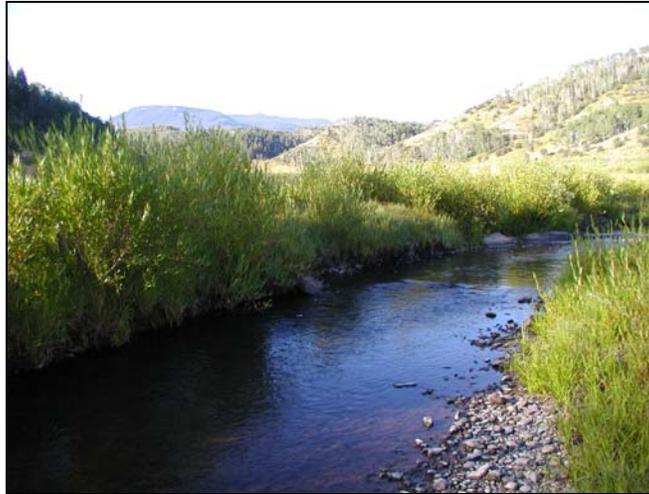
Riparian vegetation was denser in 2005 than in previous years, especially along the lower South Fork, with the high flows and wet early summer. Figure 22 shows one representative location on the lower South Fork in the pasture immediately upstream of the South Fork Bridge flow-meter site.

**Figure 22: Representative riparian vegetation along the lower South Fork. Note the shading provided to the bend pool by willow establishment.**

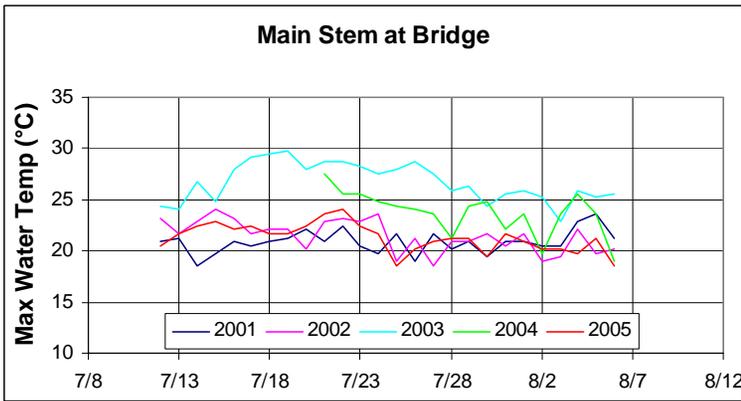
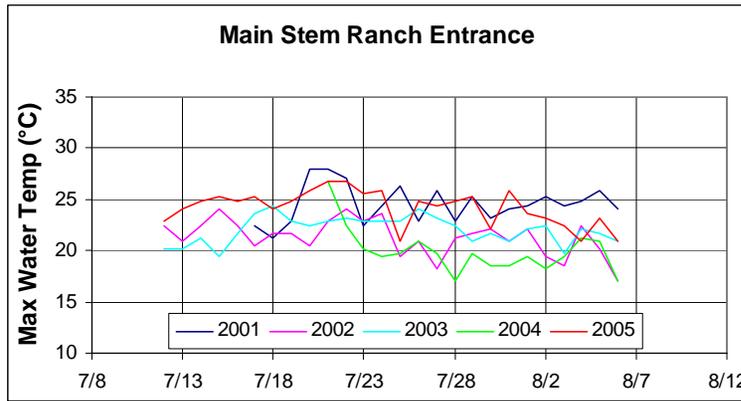
Figures 58-59: Comparison of 2001 through 2005 maximum water temperatures along the Main Stem.
