*A Watershed Management Procedure*

U.S. Department of Agriculture  
Forest Service/Northern Region

## STREAM REACH INVENTORY AND CHANNEL STABILITY EVALUATION

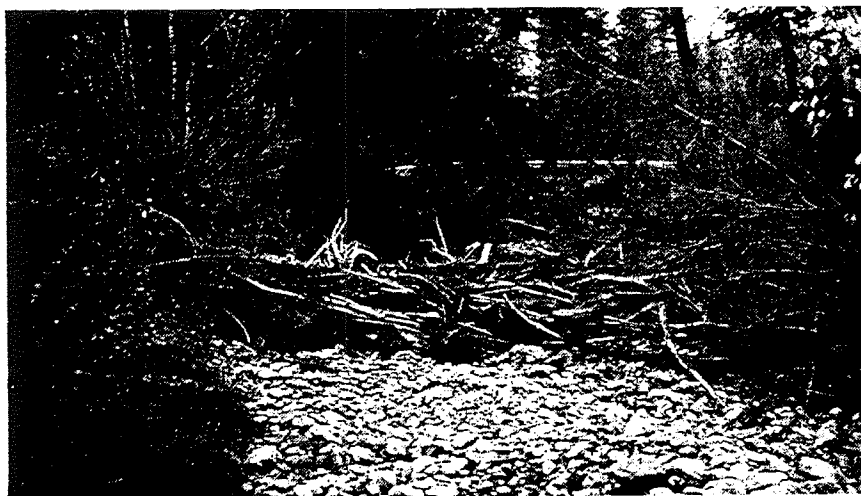
*A series of debris jams of small size materials like the one shown in the center of this photo cause this item to be rated "Poor".*

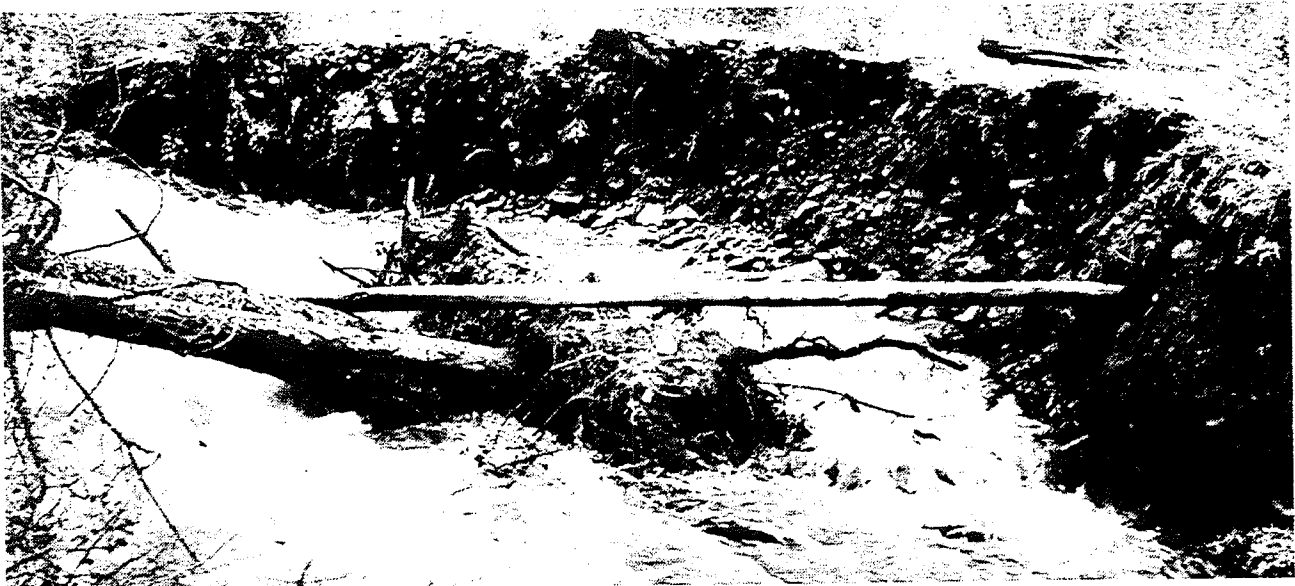
*Same location as shown on page 14, but looking upstream.  
Obstruction like this could become the nucleus of a debris jam.*

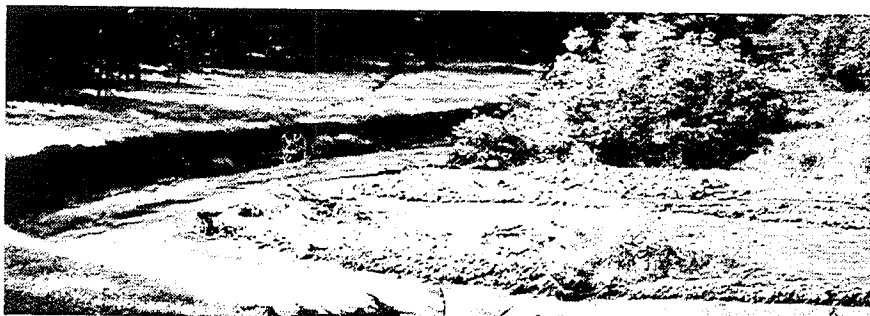
*Poor bank conditions at this bend are evident.*

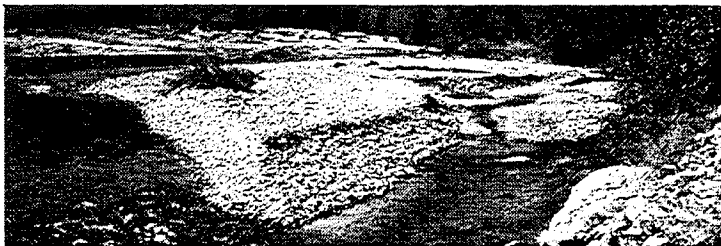
*Poor conditions are illustrated here.*

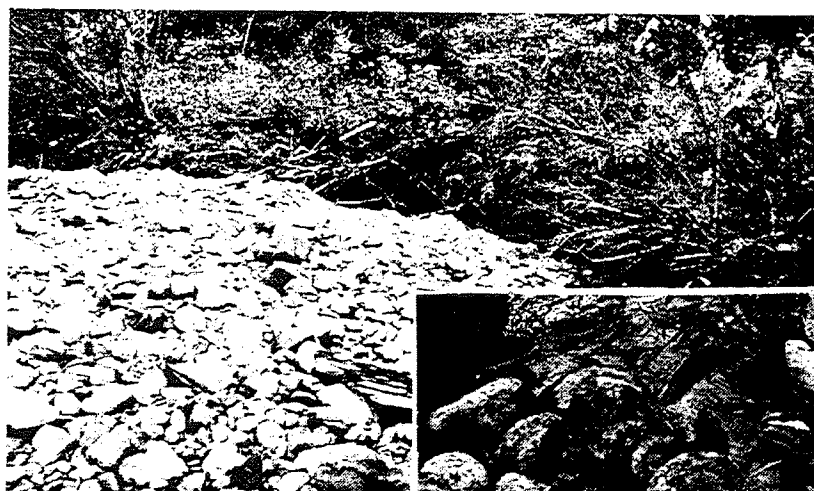
↑  
**Mostly Bright**

1. Excellent: Less than 5% of the total bottom should be bright, newly polished and exposed surfaces. Most will be covered by growths or a film of organic stain. Stains may also be from minerals dissolved in the water.
2. Good: 5 to 35% of the bottom appears brighter, some of which may be on the larger rock sizes.
3. Fair: About a 50-50 mixture of bright and dull with a 15% leeway in either direction (i.e., a range of from 35 to 65% bright materials).
4. Poor: Bright, freshly exposed rock surfaces predominate with two-thirds or more of the bottom materials in motion recently.

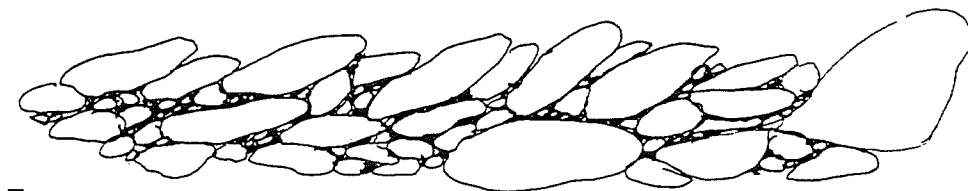
**Excellent**

1. Excellent: An array of sizes are tightly packed and wedged with much overlapping which makes it difficult to dislodge by kicking.
2. Good: Moderately tight packing of particles with fast water parts of the cross section protected by overlapping rocks. These might be dislodged by higher than average flow conditions, however.
3. Fair: Moderately loose without any pattern of overlapping. Most elements might be moved by average high flow conditions.
4. Poor: Rocks in loose array, moved easily by less than high flow conditions and move underfoot while walking across the bottom. The shape of these rocks tends to be predominantly round and sorted so that most are of similar size.

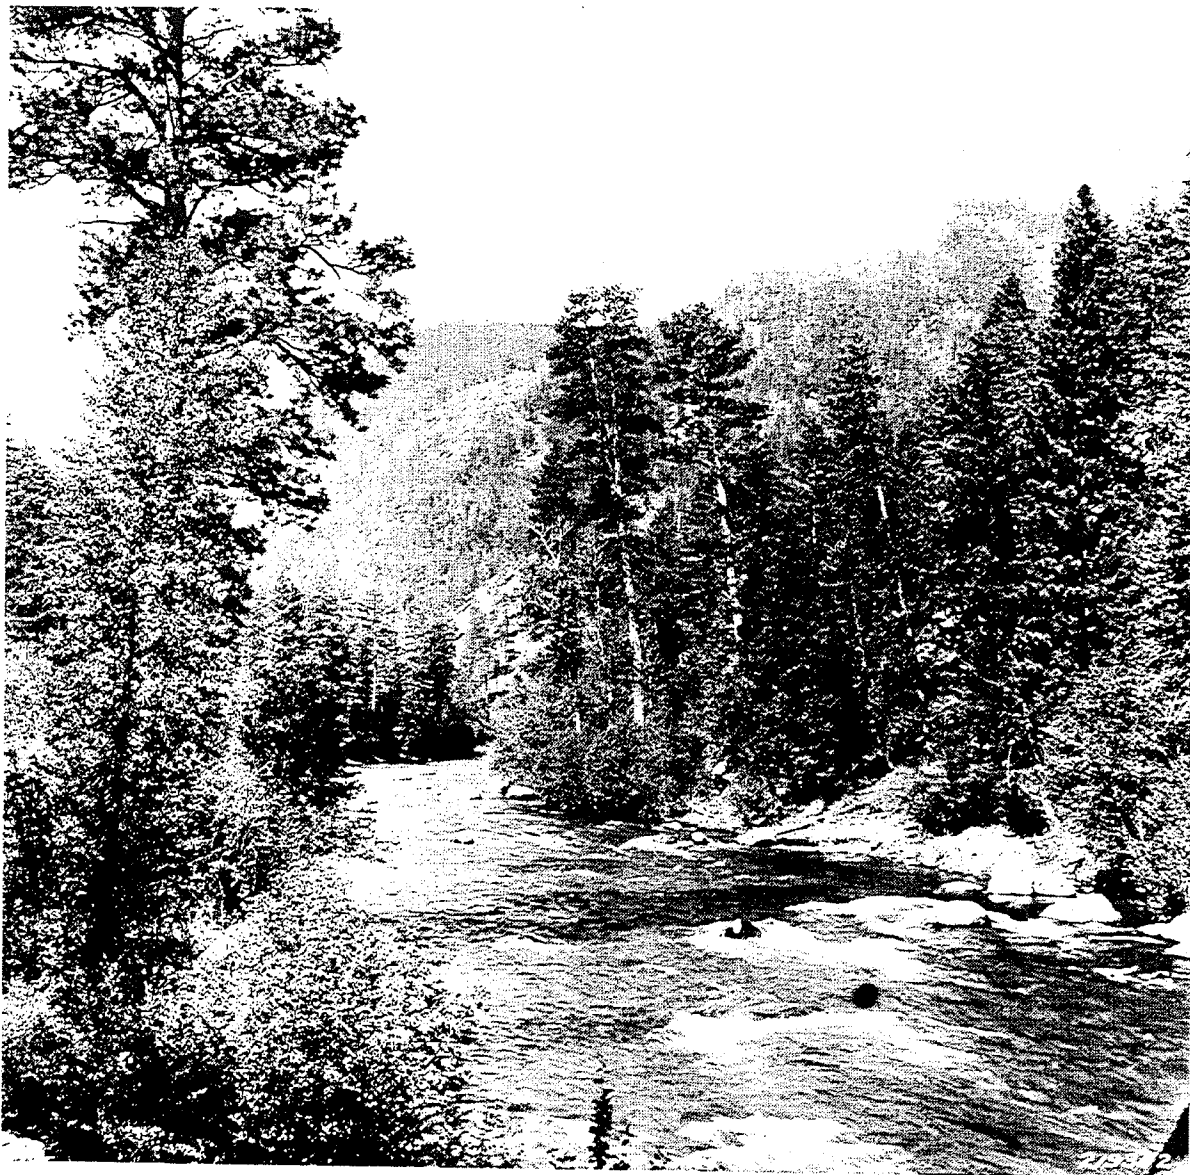
*This large stream channel reach  
would be rated "excellent" overall.*
